SUMMER 2005 HOLLOW STABILIZATION REPORT #3, 18 August 2005
By Cheryl H. Shepherd, Architectural Historian/Resident Project Manager for the APVA

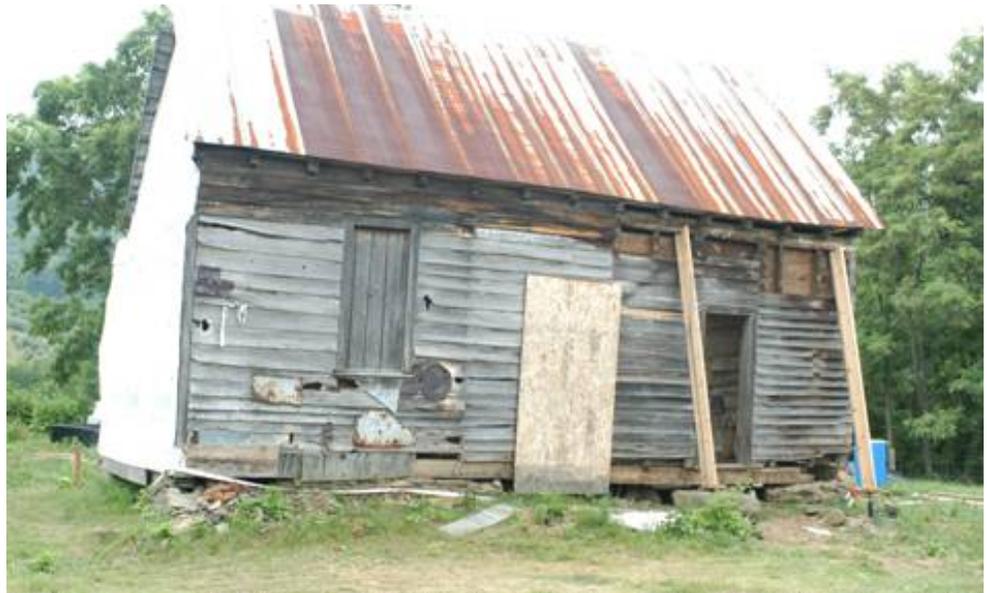
The Hollow, South Front and West Side showing just two bracing and jacking posts, July 7, 2005

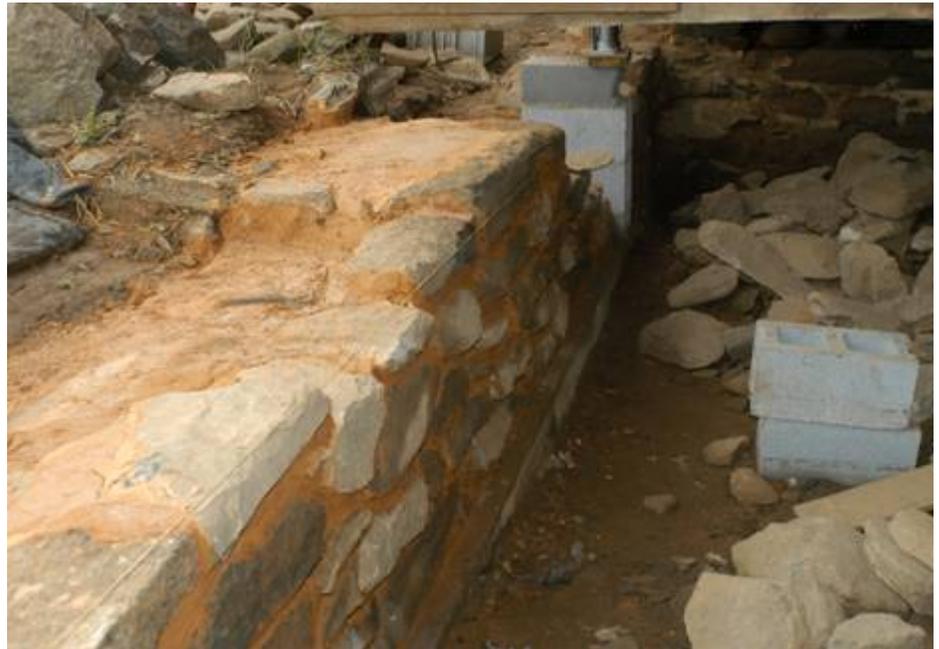
- 4. North back foundation – The dismantling of the caved-in back foundation revealed the reason the archaeologists could not find the builder’s trench in this only spot they looked except for along the chimneys. Judging by the mortar content, the circa 1895 reconstruction of this foundation surely eradicated any evidence. The first week of July, Edward and his crew had finished rebuilding the north foundation up to grade. They used clay on the outside against the soil and historic common mortar including lime putty inside and at the higher level.

New rear foundation to grade. The cinder-block jacking piers are temporary, 7 July 2005.

The exceptional masons stopped the height slightly above grade until the new oak sill is in place. He will then raise the wall up to it to add masonry support. Edward used Portland cement for the underlying footer for this foundation which is acceptable considering it is underground and desired for added support.

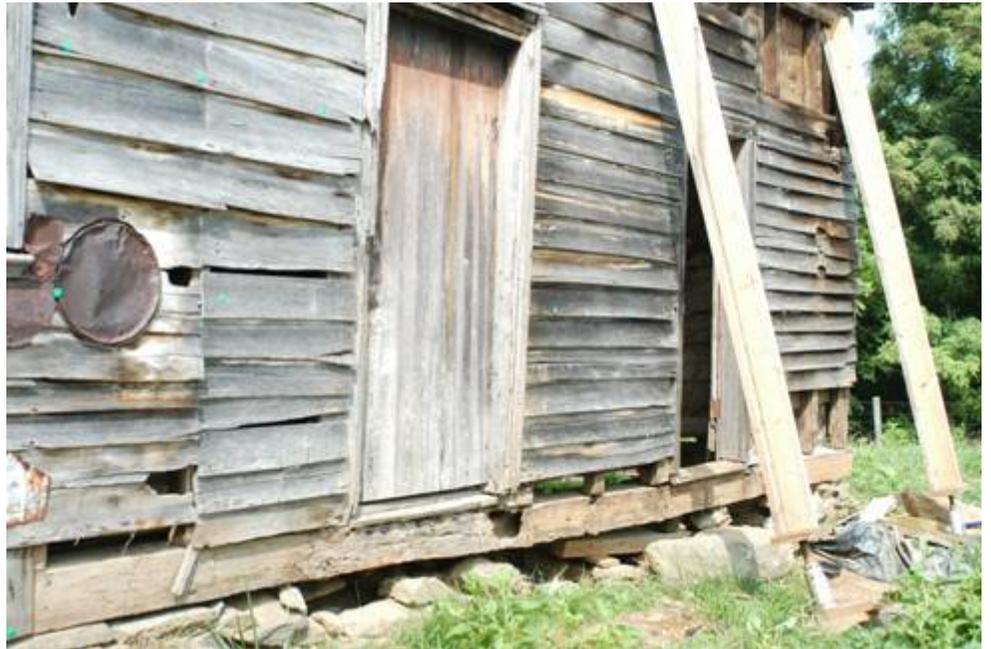
- 7. South front foundation – As a sensible means of properly stabilizing this long neglected eighteenth-century Marshall house, I recommend that we completely repair the front foundation which had collapsed under the south sill from the former window across the elevation. Since the SE corner has to be repaired, this is a stretch of seventeen feet plus another four feet at the SW corner of no support for the twenty-eight-foot long front sill. In the not too distant future, the house will start slipping forward if this is not repaired. Edward’s estimate for fully restoring this front and any additional shoring up of the side elevations is \$12,000 above the approved \$40,000 for the masonry work during this stabilization. He offered that so far his expended labor and material costs are running well within the accepted budget.

The seventeen-foot stretch of non-supportive foundation on the south front, June 18, 2005.

On July 17th, Edward requested approval to tear out this front foundation below the hole up to the inward bow several feet west of the center door where the wall remains structurally sound. His second motive was to pour a cement footer for the necessary inside jack to support the front sill for lifting and during patching. Considering the foundation stood only below grade serving no supportive use and recalling Dr. Collins's advisement that his family is committed to doing what makes sense to preserve the structure, I authorized the crew's dismantling. The jacking footer was poured, and these skilled historic stonemasons started rebuilding the wall up to grade where it has now on hold. It will remain as it was when we started, a gap above ground, although below grade and two feet beneath the frost line, the wall is now structurally sound and can support temporary cinder-block piers if necessary. Should the additional \$12,000 above the present \$95,000 top budget figure become necessary and be approved by the owners, the wall will be fully restored to support the sill.

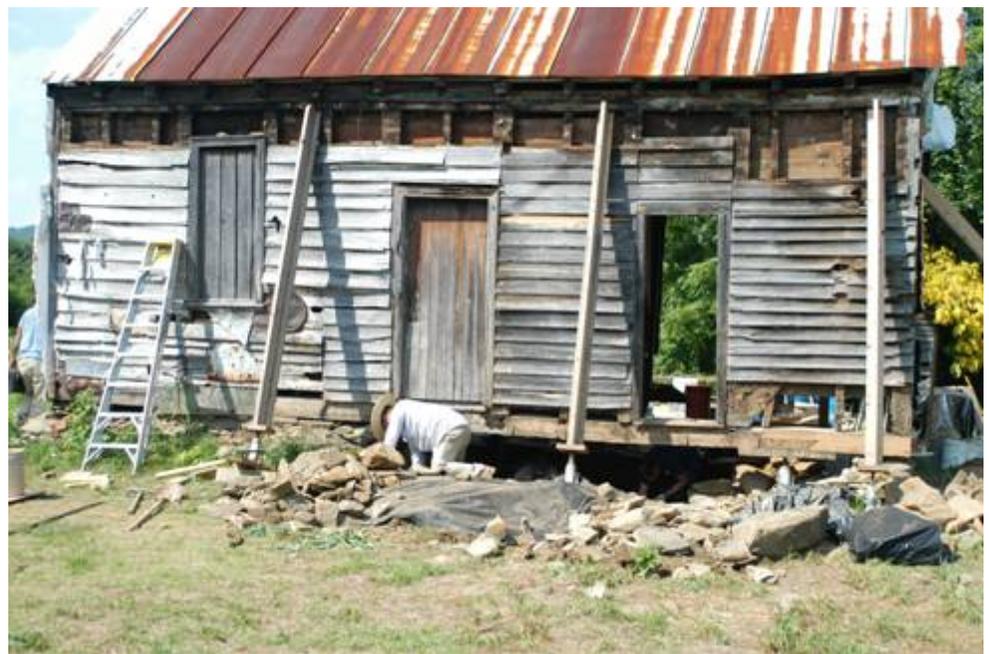
The masons are dismantling the stone foundation below grade. Note the gap at the SW corner, 20 July 2005.

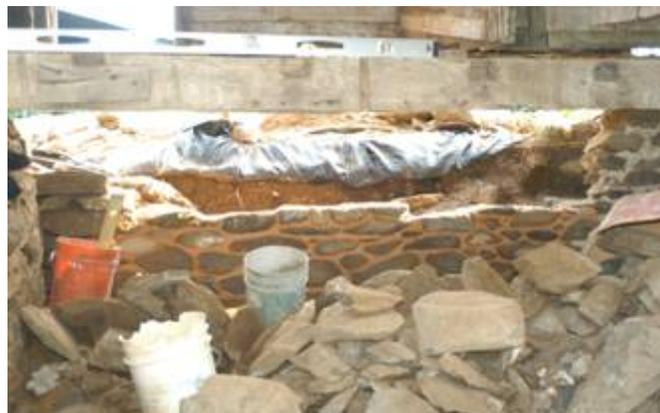
The photograph at right shows the front foundation restoration approaching grade and its stopping point until the determination of funding to bring it up to the sill, July 22, 2005.

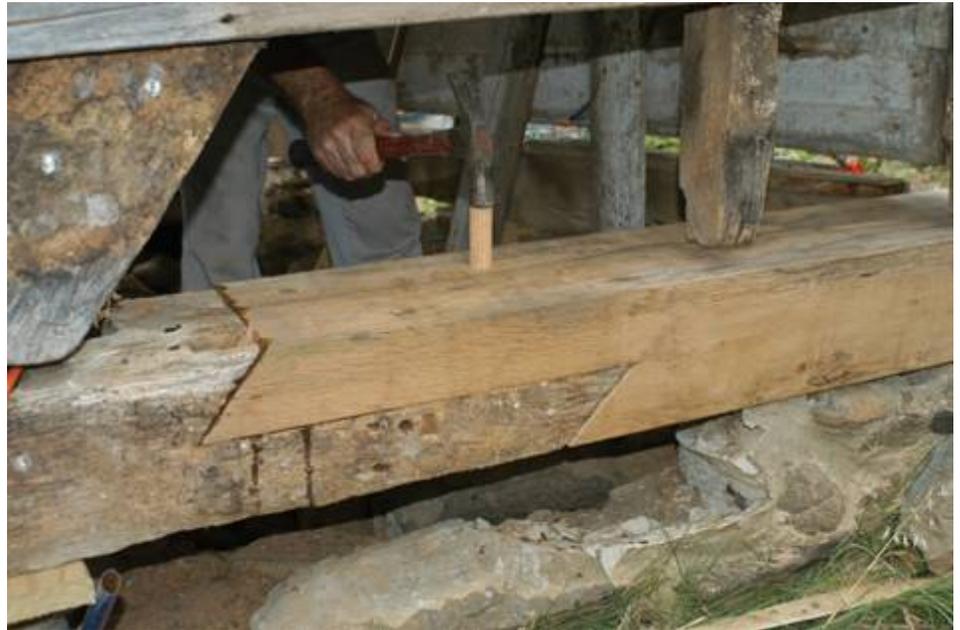
9. The south front sill has bowed in at center and had two one-foot long and nearly full-height holes under the center door jambs from continuous water penetration as well as a twentieth-century, initially crudely wire-nailed replacement timber inserted at the SE front corner. Mike removed this barely fastened repair, sawed and hewed a new oak piece, cut scarf joints on both members, tree nailed and glued the main sill and this infill member together and finally anchored the SE end to the corner post. Using approved preservation epoxies, he layer by layer filled in the holes in the center and applied a steel L-plate for additional support. It will not be seen after the weatherboards are reapplied. Lacking a penny, a 2005 quarter, set into the top of the clear consolidate demonstrates the repair date to future investigators.

Mike is hammering the peg into the scarfed sill joint in the top picture. The right twelve-inch wide hole under the door jamb is shown below. The hole under the left jamb did not fully penetrate the front sill, but the punky wood shows. The hole is substantially seen from the top, July 18, 2005.

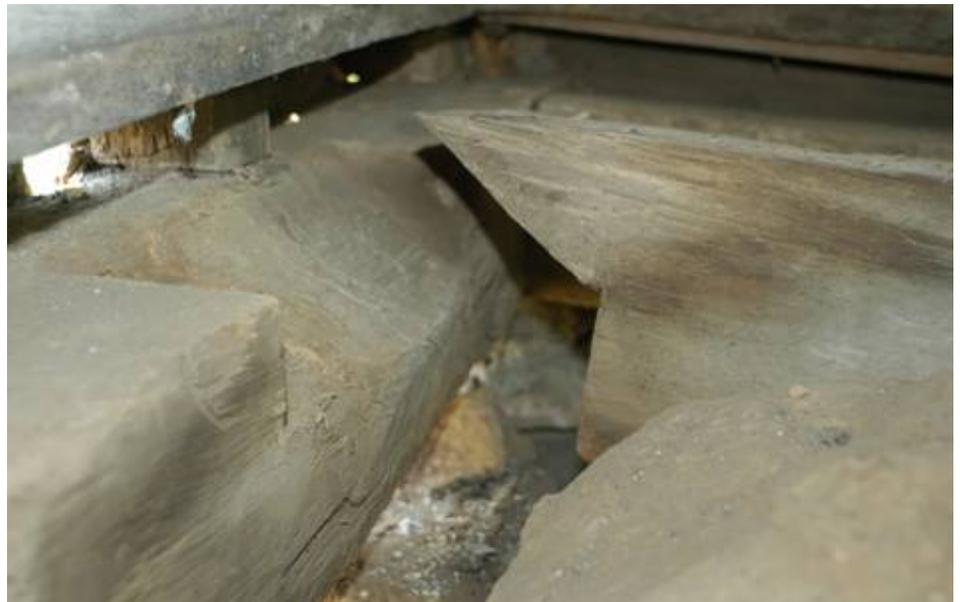
11. The floor removal exposed the never-fastened, uncommon beveled joint at the SW end of the west 10 x 8 fireplace hearth girder. This end was setting in mid air several inches above the notched receiving south sill. Although it may have laid into the notch when first constructed, the north movement of the house has long stress-pulled the timber from its proper position, carrying the floor and hearth with it. Secondly, this girt was disconnected at the center hearth point from the inferior slimly-cut shoulder in the E-W summer beam, and there was substantial deterioration at center.

Unfastened beveled end of the original west hearth girt setting high above the notched south sill, 7/20.

Ever mindful of our mission to preserve the historic integrity of this National Register house and plans for its future education, Mike and I discussed the least invasive repair. While a drilled peg hole or wrought nail would have been less visible to future scholars and investigators visiting the cellar, we ultimately agreed it would be falsifying history to now fasten as it should have been done in the first place, although it would have been cleaner and less obtrusive. Due to the center decay and repair involvement, Mike preferred the application of somewhat more invasive, but stronger, L-brackets on the sides to anchor the bevel into the notched sill and the hewn summer beam. Identifiable and datable to our repair phase, while retaining the historic hand-hewn white oak timber, this method in an infrequently-visited cellar still retains and preserves the integrity of original workmanship and materials. As he had done on the front sill, Mike layered consolidates into the center deteriorated core and anchored the member to the summer after setting it into a steel plate. None of which

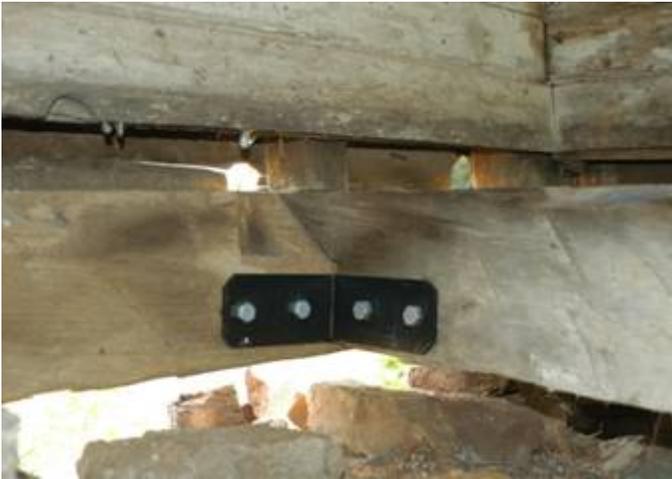
A steel L-bracket now anchors the unfastened beveled end of the west hearth girt into the sill, August 2, 2005.

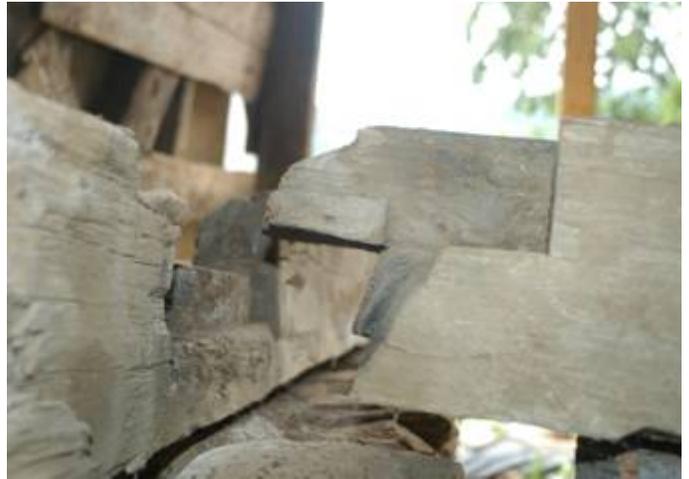
The slimly-cut shoulder joint on the summer beam and west girder at the deteriorated center hearth area, 28 July 2005.

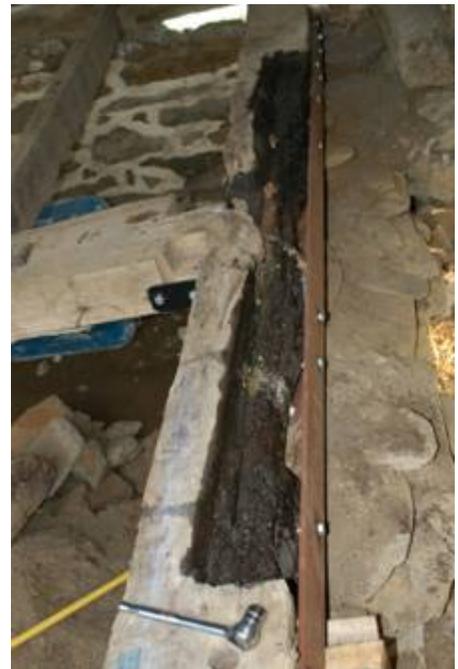
Below, anchored summer beam into consolidated hearth of girt, 8/2.

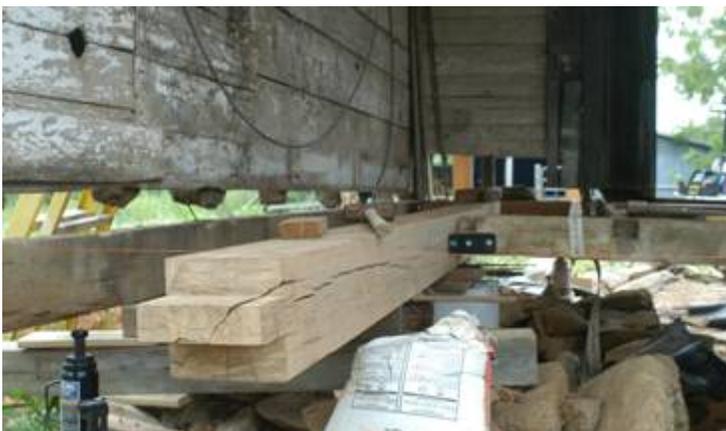
12. East 8 x 8 x 16 fireplace girder – This circular-sawn replaced timber was punky from end to end, so a new white oak member was ordered, arriving with the back sill. A ten-inch-long, full-width knot at one end was concerning, but Mike was able to eliminate much of it through his tenon and shoulder cutting. This new timber is also broadly checked from end to end, and it is wise to infill those with Abatron, another time-consuming procedure. He spent much of Monday this week hewing the inside facing the cellar because gritty dirt had splashed on the girt while stored in the lumber yard, and it kept dulling his axe. Demonstrating experience and good workmanship, his hewn side is straighter than the sawn side. Determined to move the member into position for cutting the tenons the next day, he worked later Monday night, hauling and sliding the heavy timber across his sturdy, scarfed and pegged front sill piece. During Tuesday's late afternoon storm and faster than the camera shutter, he finished cutting the tenons and had the girt so level he seemed to easily slide the front tenon into the mortise he had cut in the scarfed sill corner. The period-one summer beam, which appears to have had a double tusk tenon at this east end originally, had only the bottom tusk roughly in situ. Mike had to slightly chisel

This new oak east hearth girder at left is cleanly joined into the front sill, and the tusk tenon joint, missing its upper half, is anchored to the summer beam. The checks that even carry through the tenon will have to be filled in with consolidate. Note the straightness of the adzed interior side, 18 August 2005.

this tusk, and it then fit into his new girder beautifully, now ready for the north sill insertion.

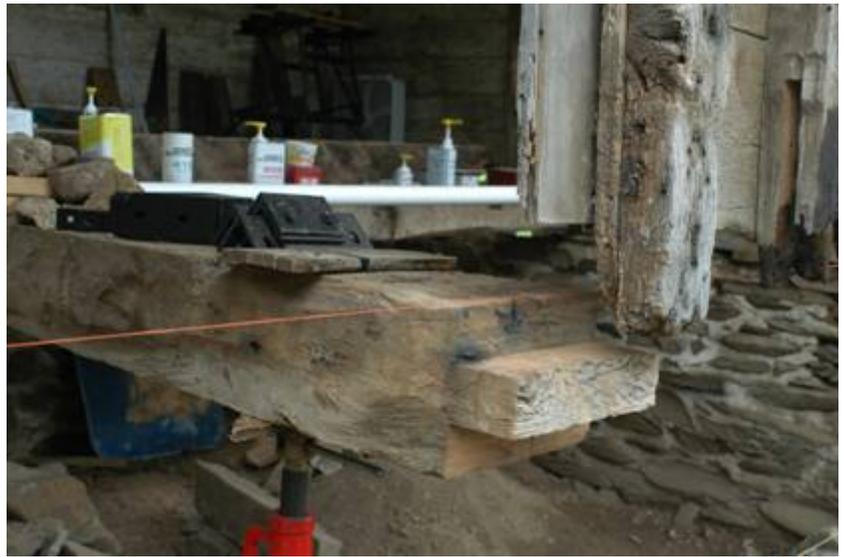
13. Center hewn girder, north of summer beam – Water probably rotted off the original tenon connected to either the period-one sill or the removed sill, but a ground hog or some fairly large critter then gnawed away at the end. It looked too short to remedy without steel anchors, but Mike found a way to get a well-sized tenon cut into the member. The gnaw marks remain on the end of the tenon as can be seen in the picture at right, August 18, 2005.

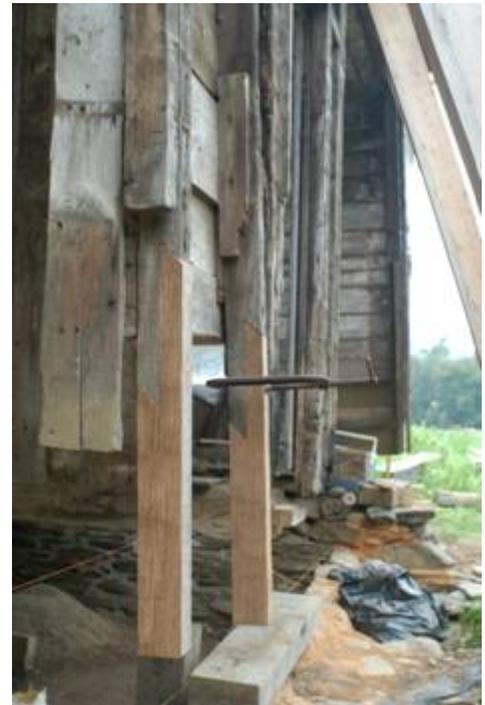
14. North back studs and down braces - Decomposition evidence indicates that this back wall has taken in water for a very long time. The outward slant of the bottom wall is easily read on the decayed lower third to one-half of these uprights and down braces. Analysis of the stone foundation suggests that the lean and problems began before the late nineteenth century. Mike numbered and temporarily removed five of the thirteen studs on the back wall, leaving eight in place, representing those that need work on their ends, either false tenons or scarf-joined new bottoms, considering the amount of deterioration. At various times throughout the weeks, he has marked and cut new mortises on the longer studs and the two corner posts for the eventual false tenon that will be inserted into these members to connect into the mortises in the new sill. Several of these uprights were rather punky but still salvageable and received consolidate to fill in holes and further preserve them. A 4 x 8 x 6 white oak member was purchased to splice into one of the down braces which Mike nicely finished.

Where new lower ends or false tenons are required, we are using recycled oak brought to the site on a short trailer for \$400. Mighty good old wood from a nineteenth-century building, the cut nails have to be removed before they are sawed down to size. Even if they are replacing too-decayed replacement timbers or original hewn wood, we determined to replicate the tool marks on all new replacement members, at least on the visible sides and date stamp the alteration in a not too obvious place. In the July 1st emailed report, Mike was shown fastening one new end to an old stud. This week he fully finished sawing, hewing, drilling and pegging together two of the stud ends as they hung from the plate – a challenging balance of coordination of materials and tools with no additional hands to hold the members together. See the August 18th photograph above right.

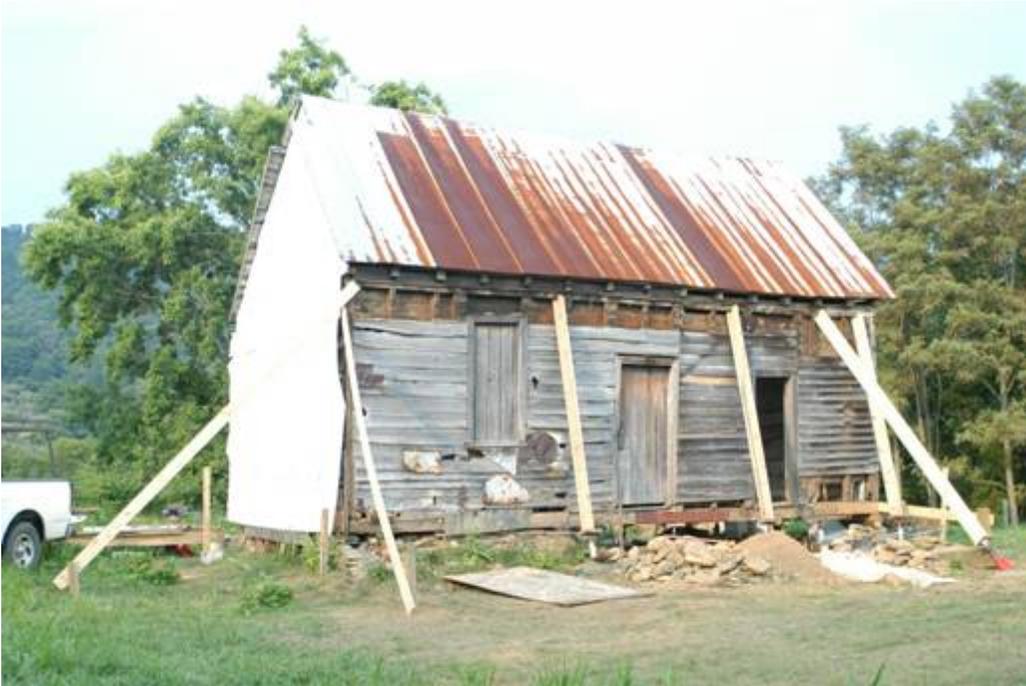
Photographed on the 2nd of August after many periods of measured jacking, notice the house is leveling quite nicely in comparison to the photograph on the first page.
