SUMMER 2005 HOLLOW STABILIZATION REPORT #4, August 29, 2005

By Cheryl H. Shepherd, Architectural Historian/Resident Project Manager for the APVA

REPAIRING THE HOLLOW DWELLING STEP BY STEP, *continued* -

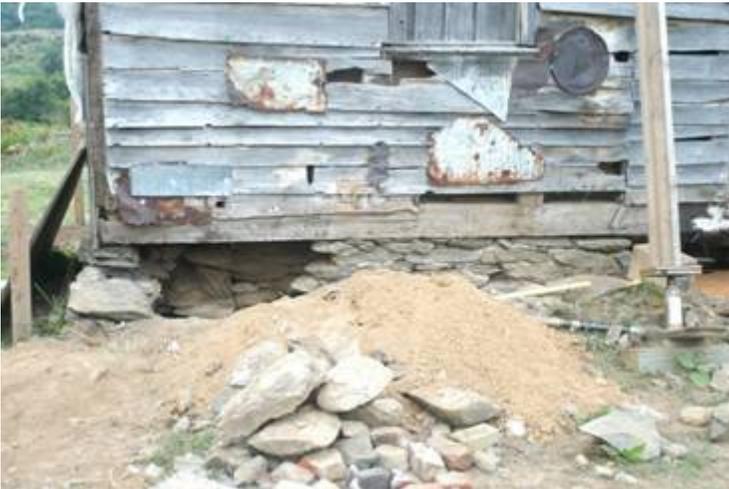
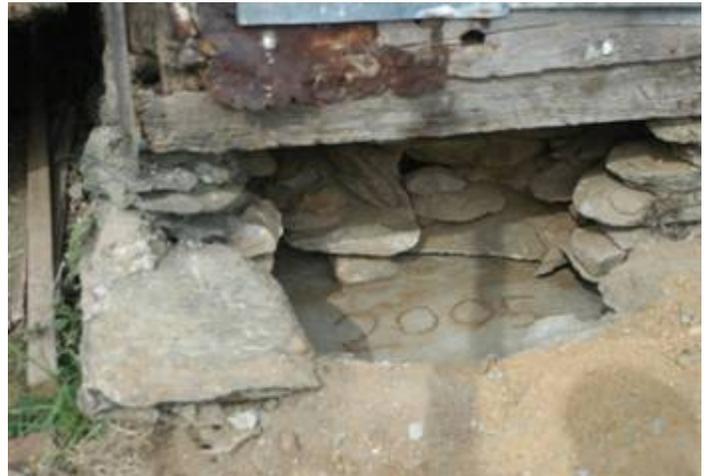
SW front corner of the foundation and the dated cement footer in the right photograph, 25 August 2005. Note the projecting stones at the left-west of the hole in the west-end foundation represent a Portland cement reconstruction of the corner. The stonemasons will be removing this failing and improperly-built corner and restoring the foundation using the proper clay, lime putty and sand mortar in the coming weeks. The only solid section of the period-one foundation is shown to the right-east of the gap. This is the original portion that will remain with the only intervention of repointing in matching light mortar.

2. Stonemasons Edward Ashby, Miguel, Francisco & Alejandro returned to further masonry work on 8/25.
 - A.) Gap at SW front corner of south foundation - they disassembled the failed foundation to the ground in the cellar, then dug a deeper footing two feet below the frost line, poured in a cement footer and wrote 2005 in the top. This new footing will support the foundation they will restore up to the sill here, using clay, lime and sand mortar. The new structurally-sound corner will join on the east the six-foot wide section of the period-one foundation that is the only safe, solid portion remaining of the 1763-64 masonry wall. Plans are to leave this six-foot section intact with some repointing using matching lime putty to distinguish it as original from the redder clay-colored 2005 mortar.

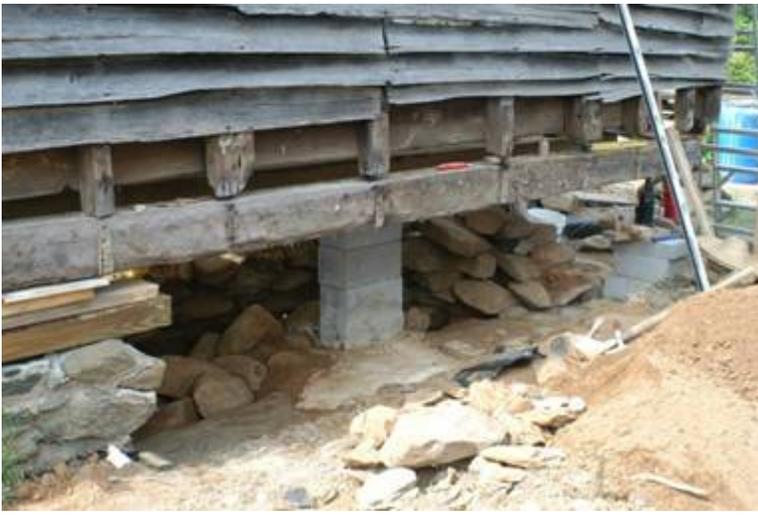
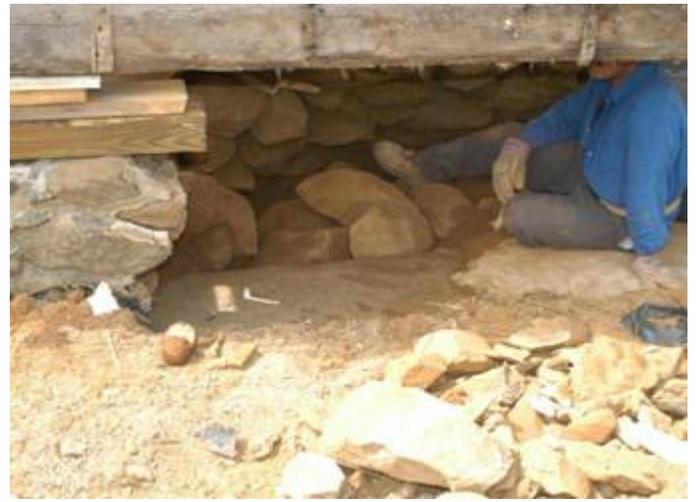
East side after further removal of deteriorated foundation, 25 August 2005. Miguel on the right has laid two broken clay pipes and an 1806 US draped bust large penny on the cement footer for the photographer to show the linear location where he found the artifacts in the soil. Outside in the sunlight, a wooden crochet ball, wet stones and a large nail may be seen. Photographs of the pipes are shown on the last page. APVA archaeologists can date through measurement of the pipe stems, and the larger pipe has a maker's signature: "Gambier Paris *M". J. Gambier established a pipe-making factory in Paris in the late eighteenth century, how late remains under study.

- B.) The stonemasons removed the rest of the east side foundation, dug a footer down two-feet below the frost line and poured a cement footing to support the wall they will rebuild using clay, lime and sand mortar at this end. Cinder block piers temporarily serve as supports for the east girt that Mike inserted and the connecting summer beam. The SE corner of the foundation remains in place as support for the joining front and side sills at this time. Edward plans to remove this unstable corner and again dig new deeper footers, pour cement and rebuild the wall perhaps finishing in week twelve, depending upon the status of work on the east side.

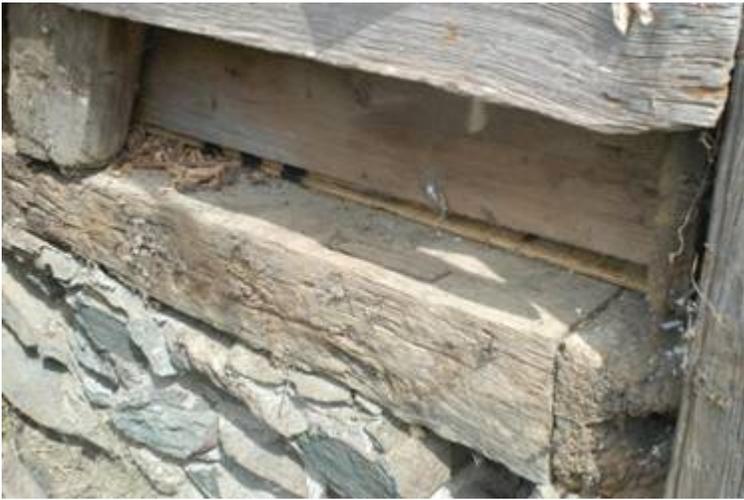
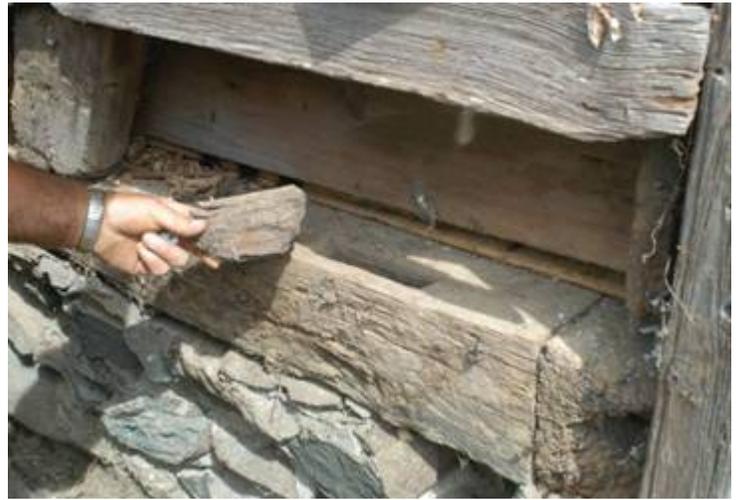
During inspection of the front portion of the west side chimney sill, the period-one carpenter's patch of a mistakenly-placed downbrace mortise was discovered. The infill block of wood was just set loosely into the mortise. Also of interest, there should be a stud between the corner post and the left downbrace as there is at the north side of the chimney, but there is no evidence of a smaller mortise for one.
