SUMMER 2005 HOLLOW STABILIZATION REPORT #5, 8 September 2005

By Cheryl H. Shepherd, Architectural Historian/Resident Project Manager for the APVA

REPAIRING THE HOLLOW STEP BY STEP, *continued, Weeks 12 & 13* –

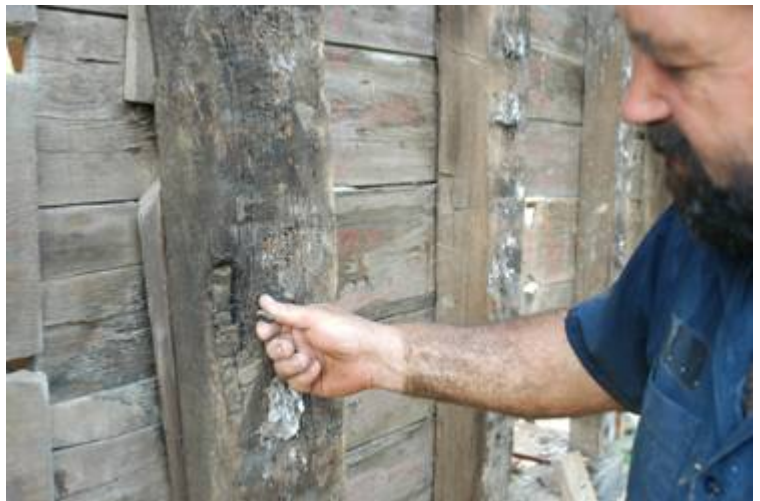
- 1) The pit-sawn broad chimney studs spaced a nearly equal distance to those existing on the west end, and the burn on the north timber.
- 2) The circa 1900 circular-sawn, wire toe-nailed infill studs and the absence of mortises in the original upper tie beam to receive the studs' tenons if no chimney was intended originally.

Edward pulls a charred cinder from the north chimney stud on the east wall, 8/29.

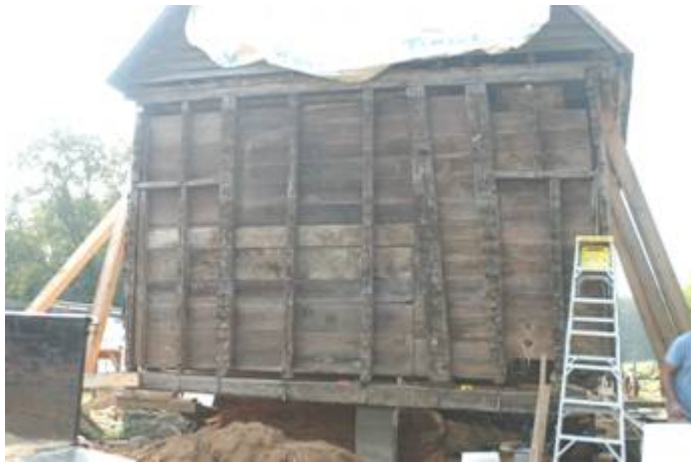
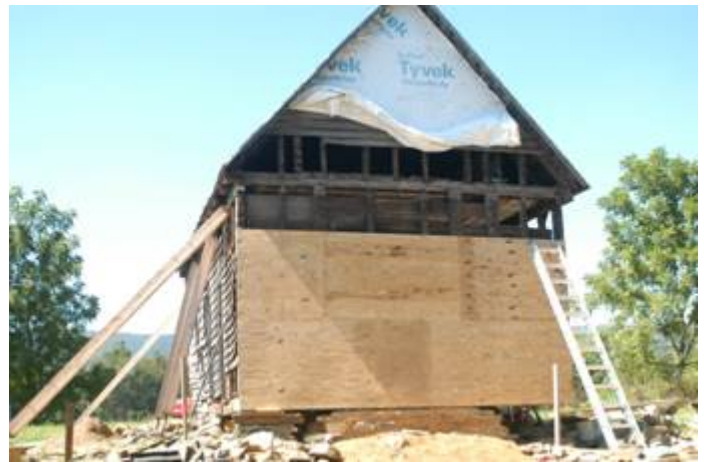
The above left photograph taken on August 29th demonstrates the northward rack of the disconnected bottoms of the north chimney stud and the south door stud on its right. Mike used steel L-braces to anchor the studs he straightened on this end to the circa 1900 sill, as several were just wire toe-nailed to it. The September 7th picture to the above right shows the screw-fastened plywood solution to brace this east gable which never had down braces because of the door openings. (The north opening may have been a window prior to becoming a door, but the evidence is incomplete.) Mike devised this solution rather than insert the down braces that were mortised for but apparently never executed and received the approval of Louis Malon and myself. The impermanent plywood now braces and holds this end in square, can be easily removed, does not falsify the architectural record with the insertion of down braces that were not inserted and will eventually be hidden by weatherboards. It is important to note that the absence of down braces made this wall vulnerable to movement and contributed to the racking of this end and back corner to the north.

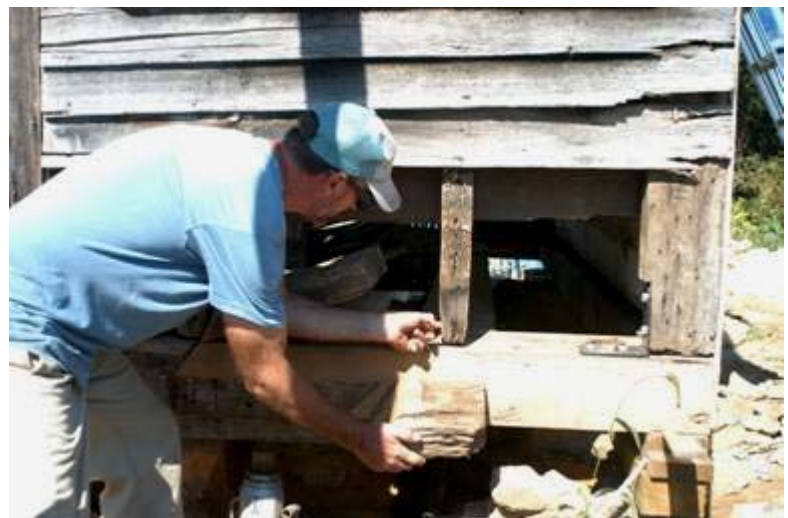
- 6) The original period-one south sill had a portion left of the hollowed-out bed or seat to receive an 8 x 8 x 16 girt exactly where the replacement member was situated and this stabilization's replacement component has been reinserted via a mortise-and-tenon joint by Mike. Unfortunately, he had to cut off this remaining half of the sill's hollowed-out end for the scarf joint he had to make to piece in the replacement corner. Note that the SE end of that sill and half of the bed had been sawn off previously in circa 1900.

Mike demonstrates where he found the hollowed-out sill in alignment with his positioning of the hearth girt, visible in the shadow behind the stud he points to.

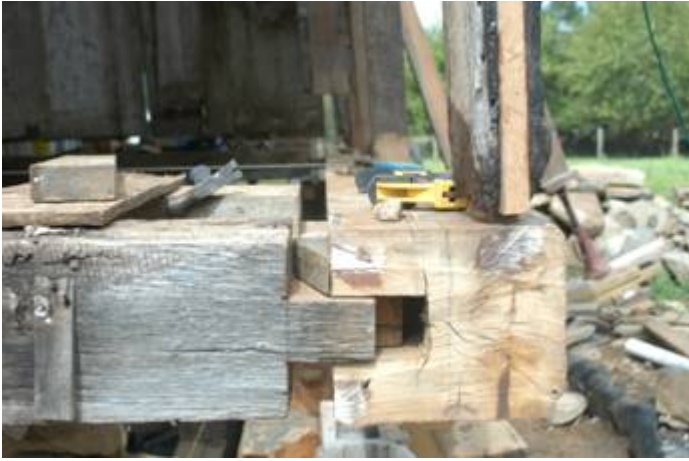
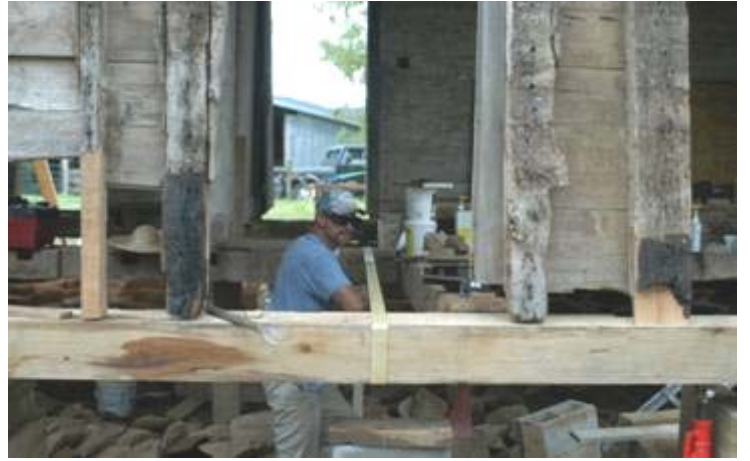
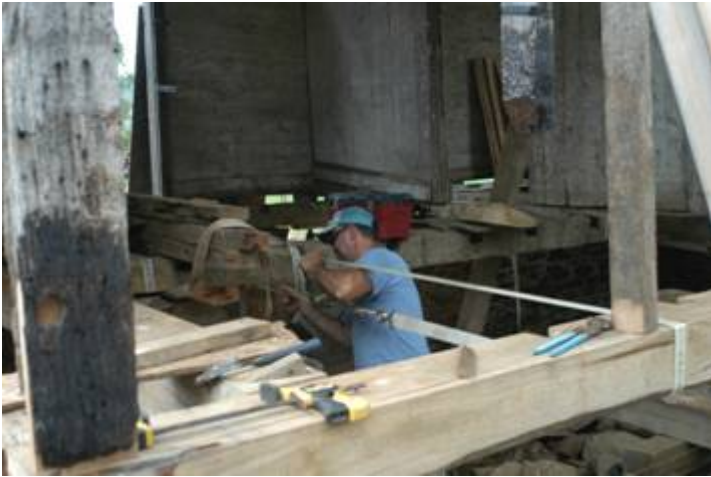
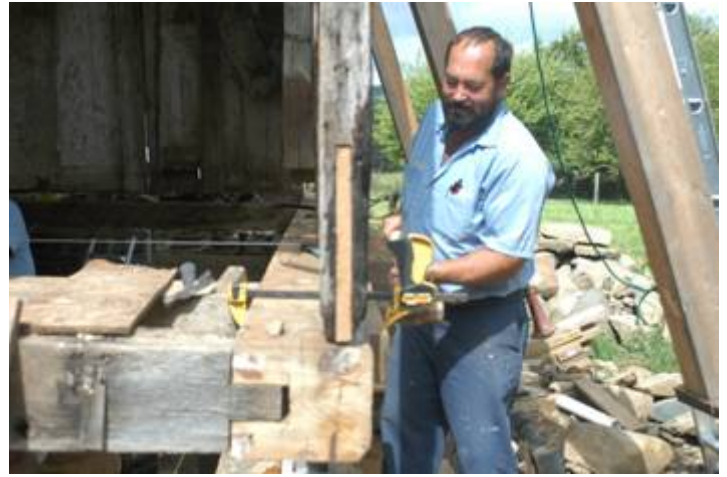
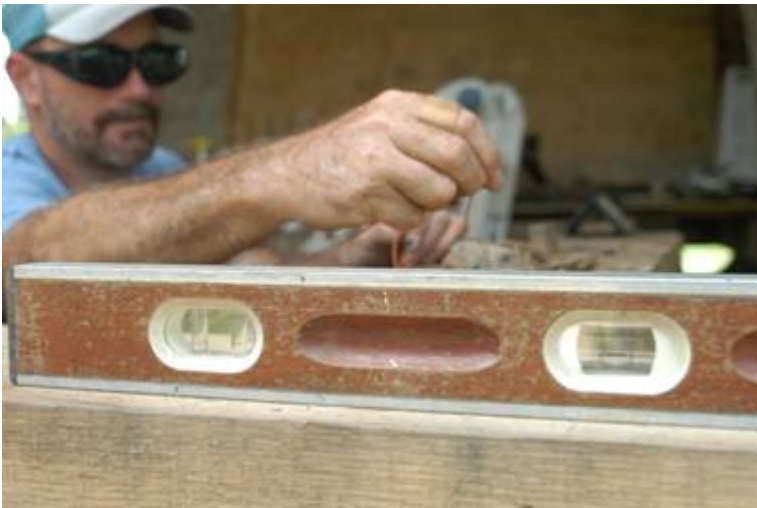
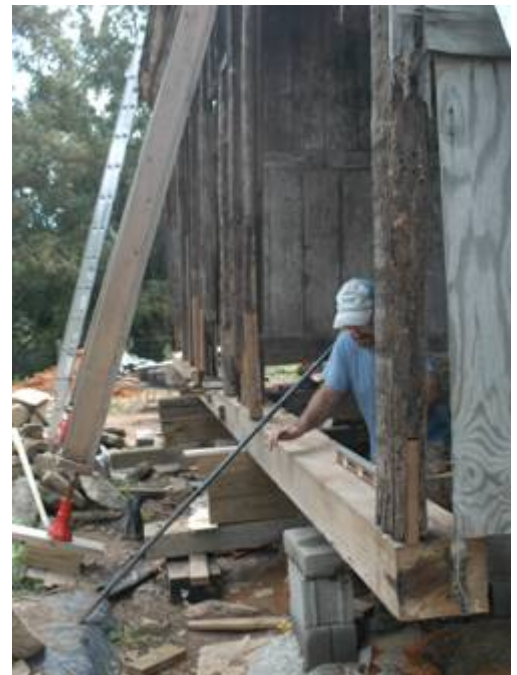
Ahead of the photographer's arrival, Mike had nearly single-handedly completed strapping and lifting the south oak sill into its receiving vertical and horizontal tenons. However, he good-naturedly accommodated documentation of the significant event by gently loosening a few still unfastened joints and straps for partial re-creation. Proving more stubborn this time, Edward joined the effort to lift and push the sill into receiving tenons. Note to their credit, the sill is perfectly level and the tenons are fully in place in the two bottom pictures, 8/31/2005.

2. South sill – Mike managed to finish positioning the new oak sill and setting the tenons of the vertical studs and corner posts as well as the horizontal girders into the timber. He double-pegged the girder joints and will later peg the major uprights.
3. Foundation work – Edward, Miguel, Francisco and Alejandro continued to restore the foundations including the interior east wall, as much of the east end wall as carpentry progress and jacking permits, at the SW front corner and south front. Where the stone has met the sills, they laid them in a final bed of sand and lime atop the foundation.

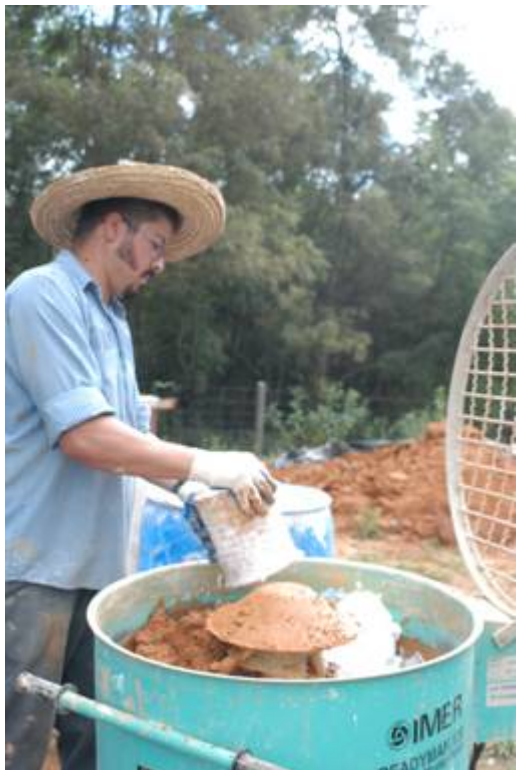
In the photograph at left, stonemason Alejandro mixes lime putty into pure mud clay, finely sifted sand and water to render a historic common mortar which is of the utmost importance in restoring masonry dating from colonial times through the late nineteenth century. Below, Edward restores the front SW corner using the mortar Alejandro has spent hours mixing. This common mortar requires slow seasoning or hardening before a hard frost. Therefore, the foundation restoration needs to be completed before 30 September 2005.

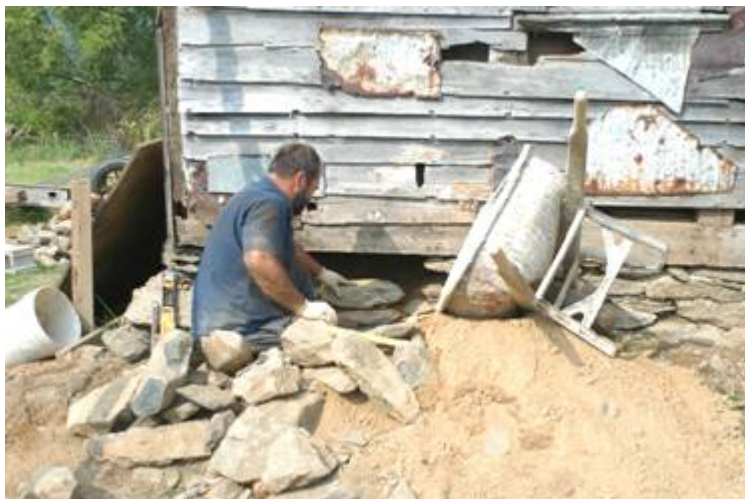
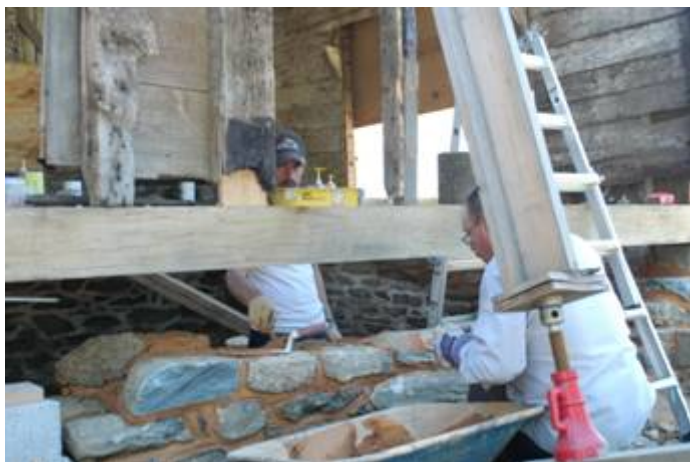
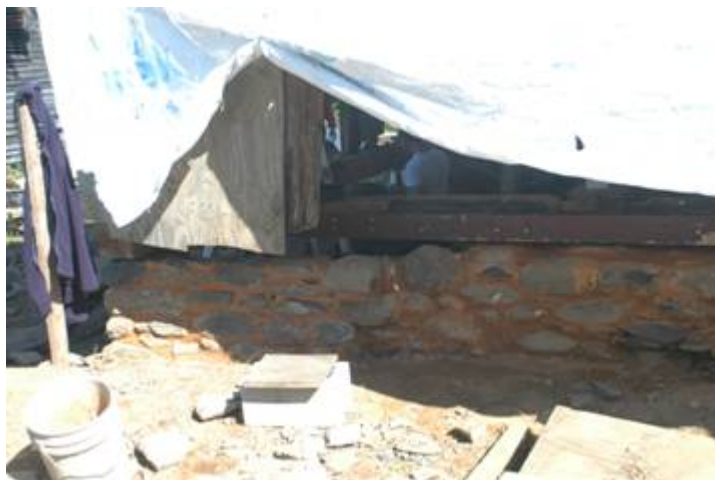
Above left, Francisco and Miguel are raising the south back foundation up up to the new oak sill. The image to the right exhibits the restoration of the exterior portion of the underpinning for the west fireplace girt and the northwest outside foundation up to where the removed stone chimney will someday return, 7 September 2005.

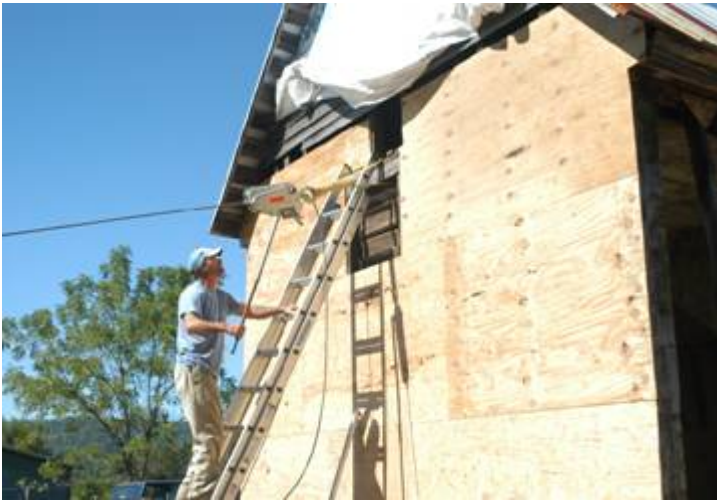
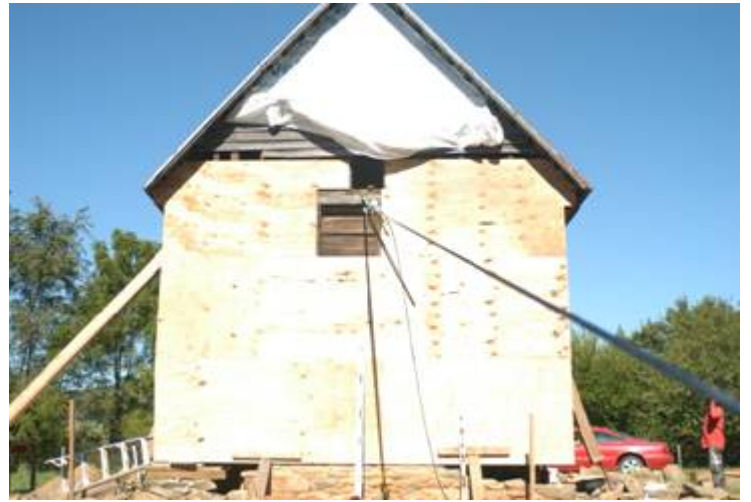
East gable end in above photographs taken 8 September 2005.

4. East to west lean – A recent storm with high winds and heavy rains loosened the tension on the jack supporting the diagonal brace at the southwest corner of the west elevation that Mike had erected to support and push the upper level of the house eastward back into plumb. Dissatisfied with the resulting two-inch slippage and after his plywood bracing attachment to the east exterior wall, he wrapped a strap around the second-floor tie beam on the east gable and cabled the other end to a tree down the hill. He then cranked to increase the tension on the cable and has decided to leave it in place for awhile and take level readings daily. Mike hopes the building will gently give in to the tension and then become contented in a level state. All workmen and visitors shall maintain a vigilant eye for safety on this side.

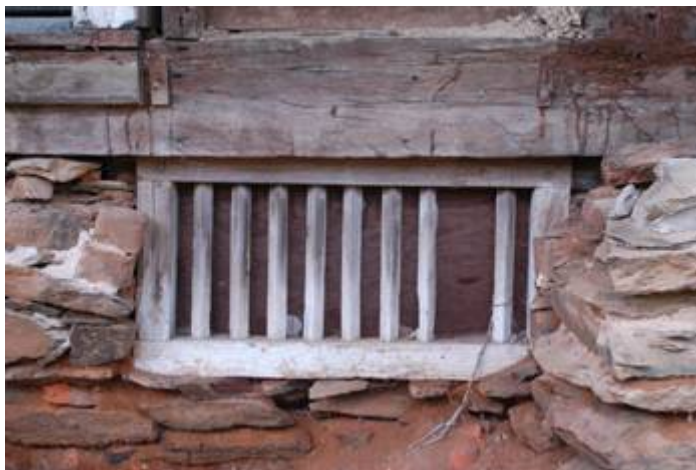
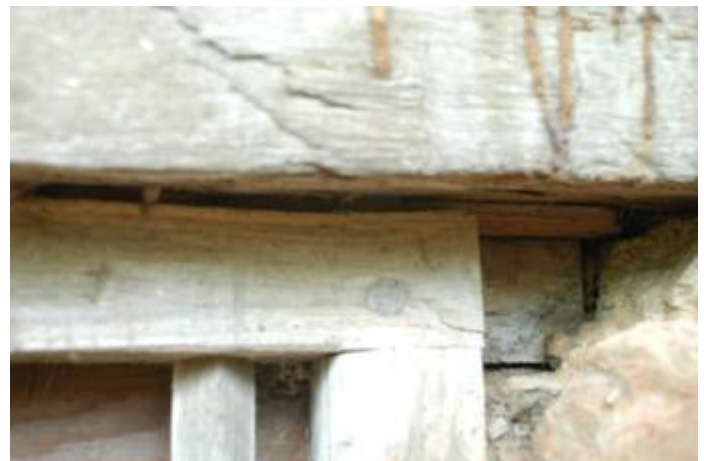
Cellar window decision after consult with Louis Malon, Director of Properties, APVA – The team has unanimously agreed to execute option #3, inserting one cellar window on the front foundation and one diagonally northwest in the rear. We qualify this decision as a practical ventilation measure taken without fully conclusive evidence of period-one existence of cellar windows at The Hollow beyond the wrought-nailed lathing strip shims under the sill above a wide hole with a remaining half jamb in the front stone foundation, as documented in year 2000. Additionally, the extension of the west end's foundation beyond the back wall and the straight-cut stones four-feet to the east in the back, not original, foundation provide some indication of a suspected cellar entrance near the northwest corner. We do not have certain architectural evidence of the size or placement of cellar windows on The Hollow but make this decision on the likelihood of some traditional method of lighting and ventilation into that useable cellar space. The model for the design and dimension comes from Yew Hill built for Thomas Marshall's friend and surveying colleague in 1760-61 about four miles distanced on Route 17 south of Delaplane. During measurement of Yew Hill's hewn and pegged windows, a shim strip was discovered at the top of the north window, such as the lathing strips under The Hollow's front sill. A mesh metal screen applied to the inside of the proposed windows will prevent animal invasion through the nine vertical pickets, and a board-and-batten awning shutter will protect the exterior of the opening. Below are pictures of one of the 18" H x 34" W cellar windows and the shim at Yew Hill.
