SUMMER 2006 HOLLOW STABILIZATION REPORT 1, June 17 – July 7

By Cheryl H. Shepherd, Architectural Historian/Resident Project Manager for the APVA

REPAIRING THE HOLLOW STEP BY STEP . . . Weeks 1 through 3

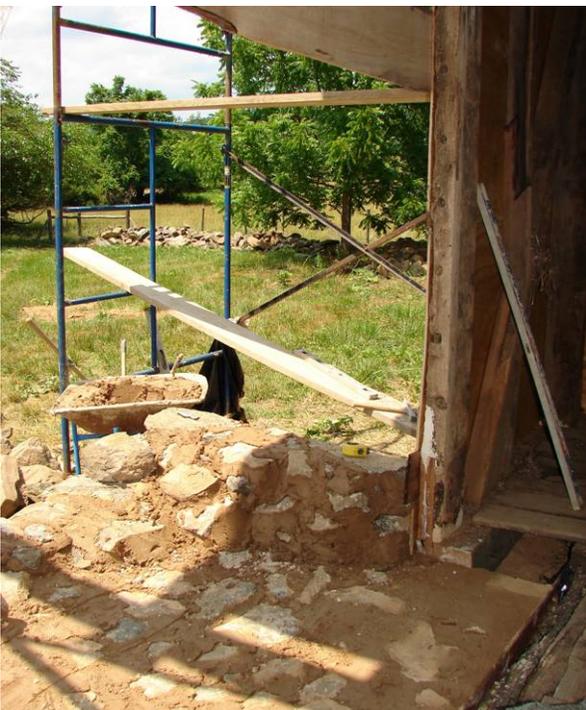
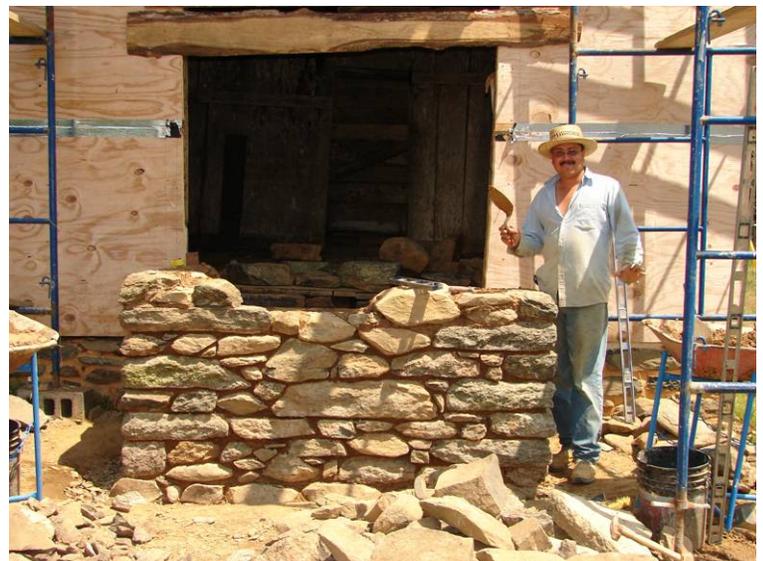
On June 20th, Alejandro steps back to yield a good view of the rising chimney. The hearth foundation is shown on the left.

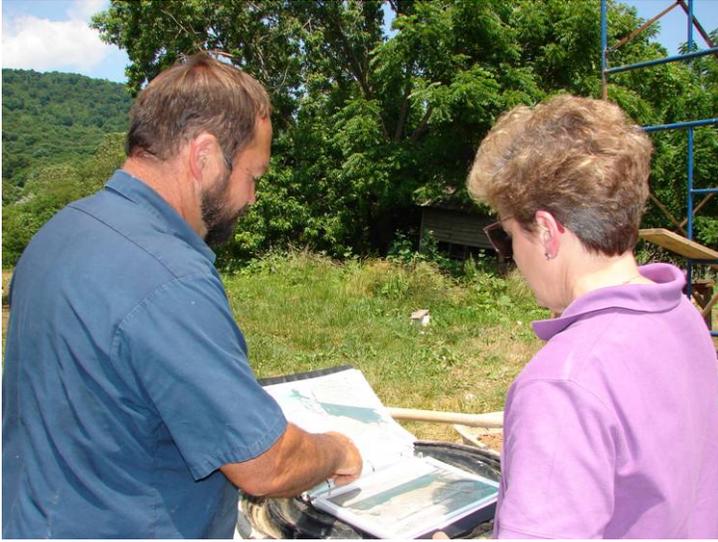
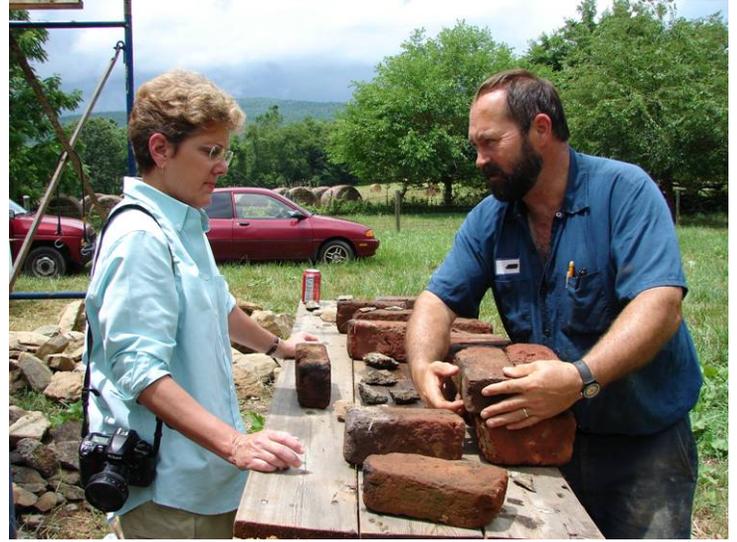
Below, Edward and Cheryl refer to documentation of the dismantling and place the removed arch bricks into various patterns while reading their shapes, markings, mortar and decorative residue. No recognized architectural pattern emerged by stacking the bricks with their plaster and whitewash residue toward the front, and the haphazard applications moved them to realize that they received the coatings in their varied positions after being reused among the rubble enclosing the fireplace opening.

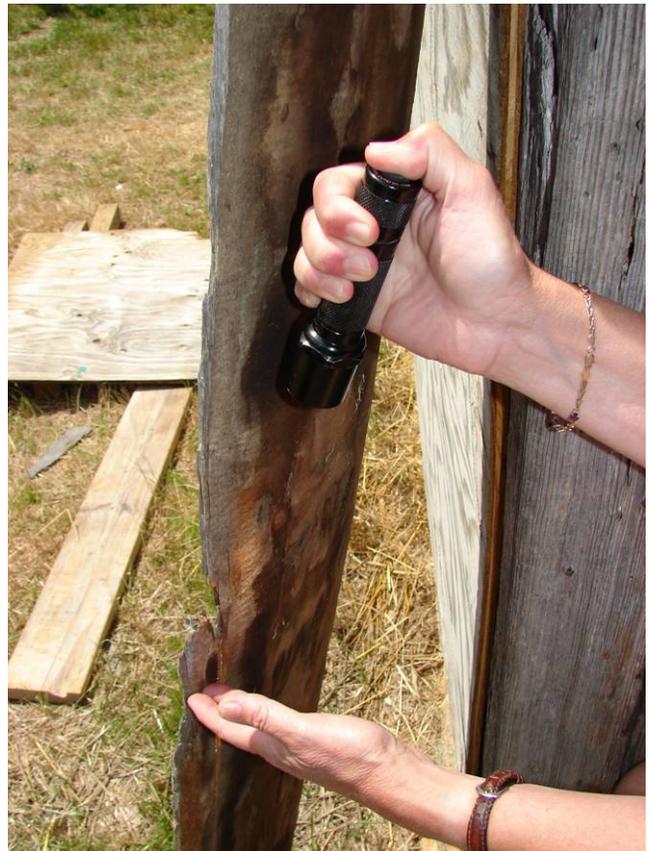
Over the winter, one of the few remaining period-one weatherboards west of the center door on the front fell off of the house. Its wrought-nail fasteners remained in the studs, but the expansion of the nail hole and the encouragement of strong winds dislocated the board. While two smaller boards had fallen from under the eave of the west gable in the last two years, the heavy weathering on their backs rendered the saw marks unreadable. This weatherboard displays the expected pit saw marks, but it is to the credit of masterful and steady sawyers that the cuts are quite even until an infrequent waver upward or downward. Cheryl studied the impressive workmanship a long time before becoming fully satisfied that the board was pit sawn from a log, rather than mill sawn like the later, circa 1780 inside sheathing.

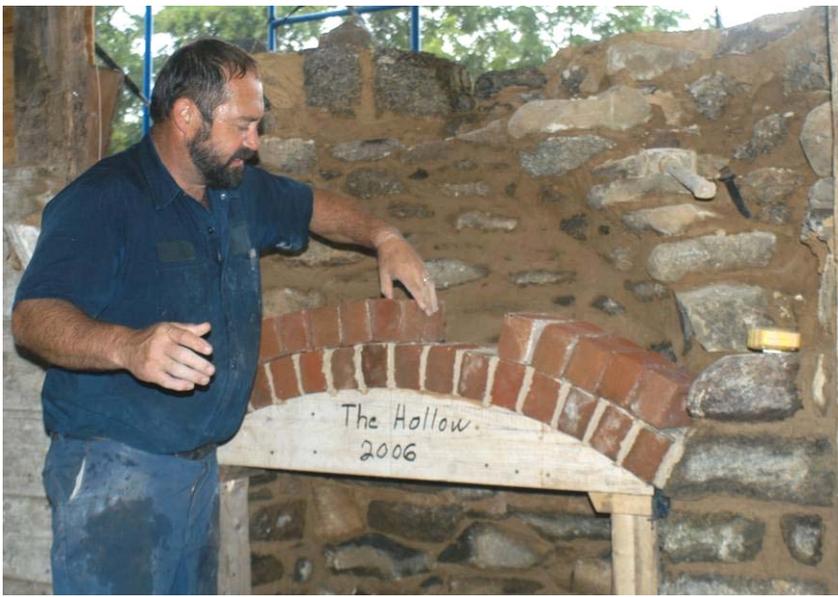
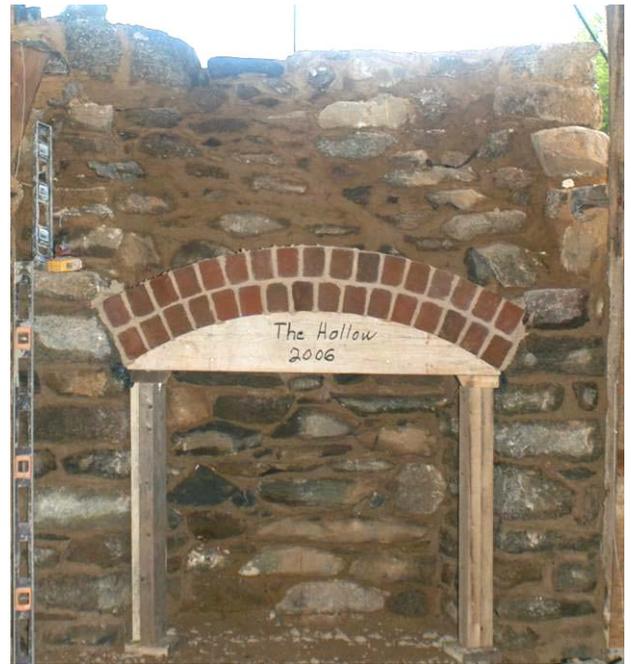
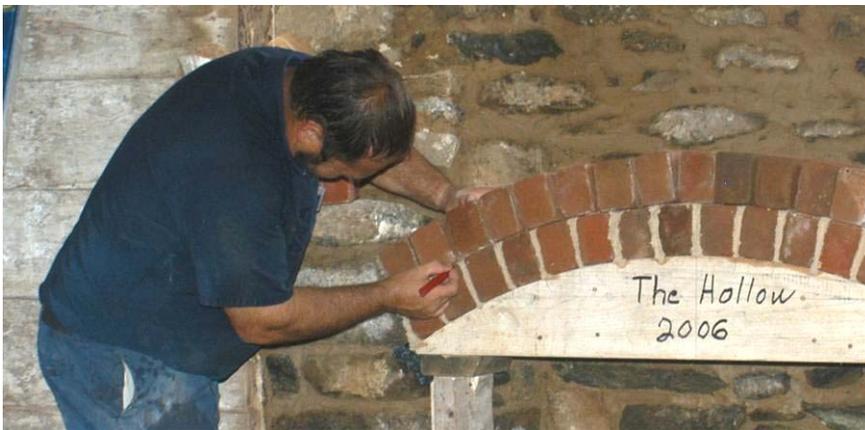
On Wednesday, July 5, Edward builds the brick elliptical arch above the forty-five-inch-wide fireplace. He first fashioned a wooden form which will be removed next week, although he could have pulled it out after inserting the last brick. It is best left in place when the next stone courses are laid. In the top left close-up, the beginnings of the chimney throat are curving toward the center above the arch. At left, Edward has carefully placed the top course and is marking where he wants their joints to fall. The finished arch is shown in the above-right picture.
