## SUMMER 2005 HOLLOW STABILIZATION FINAL REPORT #5 - WEEKS 14-20

By Cheryl H. Shepherd, Architectural Historian/Resident Project Manager for the APVA

REPAIRING THE HOLLOW STEP BY STEP, *until the season's closure in November* –

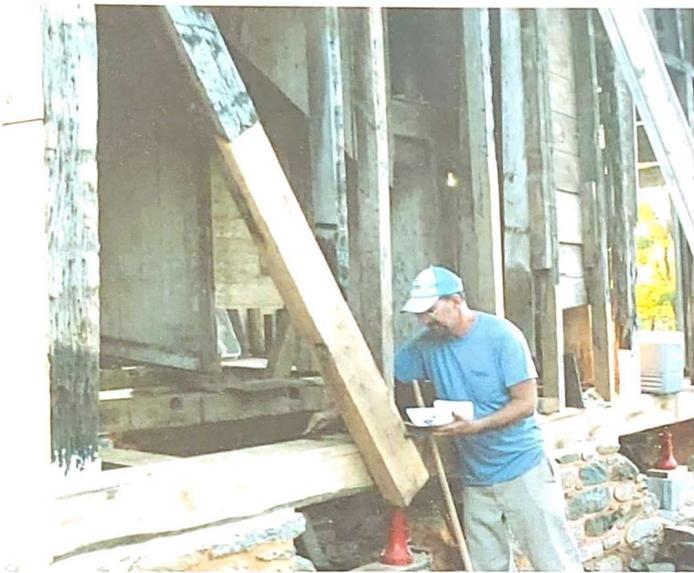
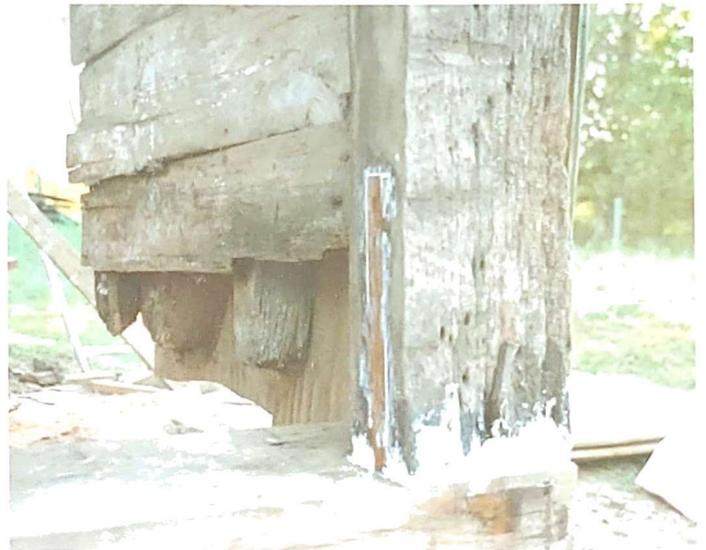
Both photographs above show the wood epoxy treatment on the corner posts and studs on the north back wall. Mike, at left, has the repaired west down brace in training position to acclimate the somewhat resistant member to its proper position before cutting the joints and finally pegging the timber into the sill. Mike's new false tenon and consolidation of the northwest corner post along with the rotted-off ends of the studs on the west side are shown in the picture on the above right. Below right, the sun highlights the consolidation of the rotted joint area of the down brace and the southwest sill. Closely inspecting the bottom of the down brace at center-right, one might notice the four arched gouge marks added by the original carpenter to designate the matching location of these joints and timbers. Generally, early timber framers used Roman numerals to identify matching mortise and tenon joints.

Since setting the north oak sill, APVA carpenter Mike Adams advanced the reinforcement of several punky framing members on this back wall with Abatron and/or West System wood consolidates. He placed the heavy down braces into the corner posts and cut the mortises in the sill for the tenons of the braces before treenailing (wood pegs) the timbers together. As he had done on all new timber, Mike stamped 2005 on his splice.

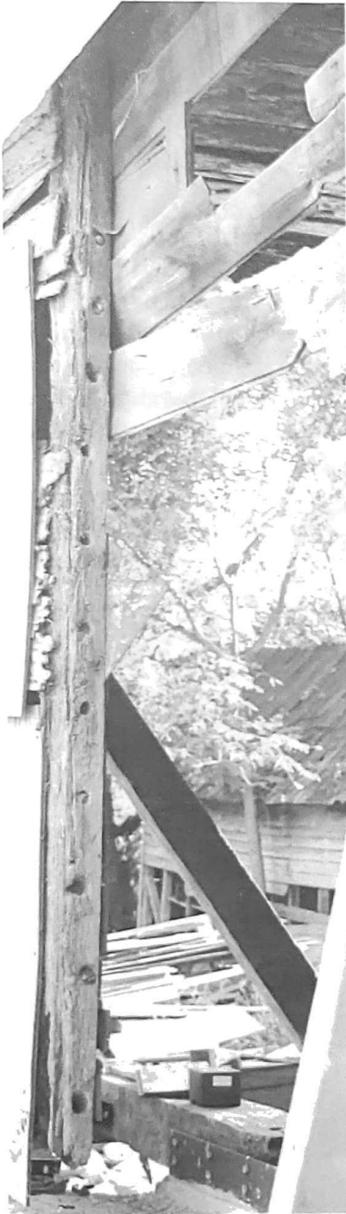
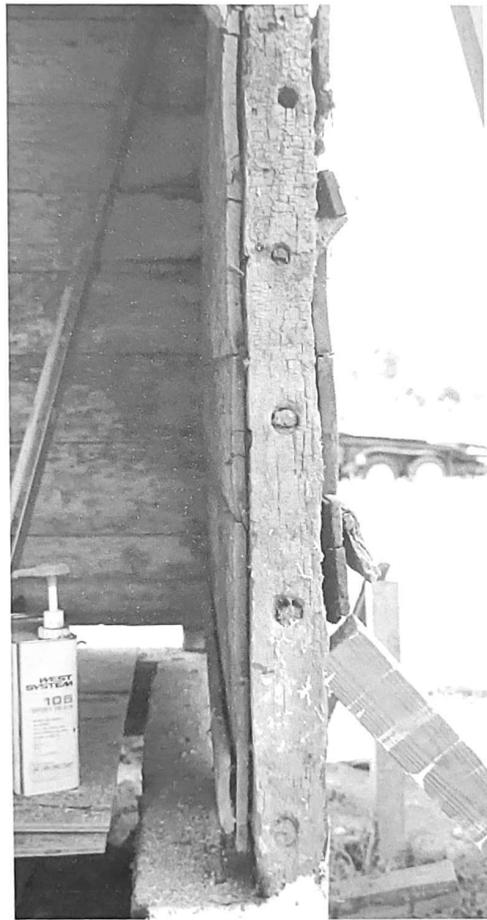
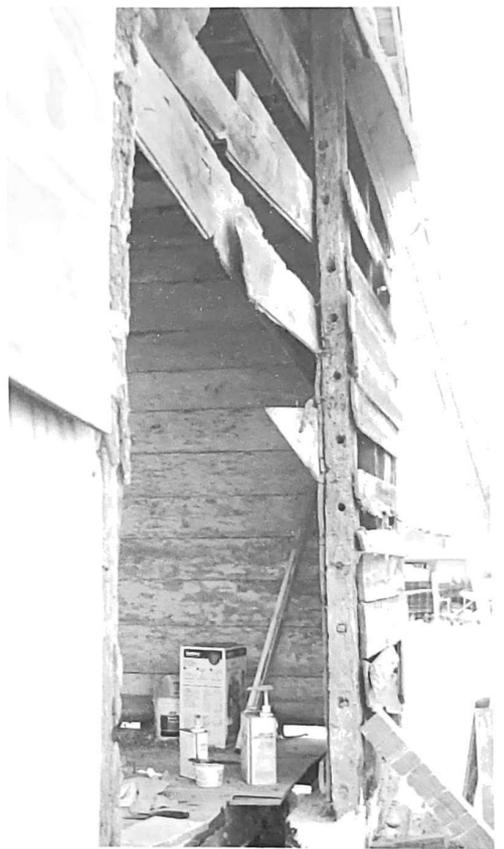
chimney in 2004 revealed for the first time that the mortises continued nearly to the second-floor plate. Before the exposure, the curious pattern could only partly be seen beside the enclosed fireplace inside the west hall. Measuring from the grade upward, the eleven mortises do indeed closely line up on each side. Mortises M2, M4, M10 and M11 on the left-north side retain broken-off treenails as do Mortises M1 through M5 on the right-south side of the chimney opening. The treenail remnants are significant evidence that demonstrate the execution of a wooden chimney on this west gable prior to construction of the stone chimney. Although wooden chimneys were outlawed before 1763 by the House of Burgesses, member Thomas Marshall apparently needed to quickly raise a chimney on his manor house at The Hollow and constructed one for the first season. Probably before the winter of 1765-66, he had quarried adequate stone to build the stone chimney after pulling down the temporary wooden component. Typical of colonial masonry chimney construction, the feature had a free-standing stack above the shoulders. Built with very rough rubble, the stack began to fail rather early in its history causing it to lean nearly thirty inches into the house by 2004 when it was dismantled to halt the weighty pressure on the house.

The left-north chimney stud is pictured on the left. At center, the bottom of the right-south stud clearly exhibits the broken treenail remnants, while the far right image shows the full height of the pierced and weathered upright.

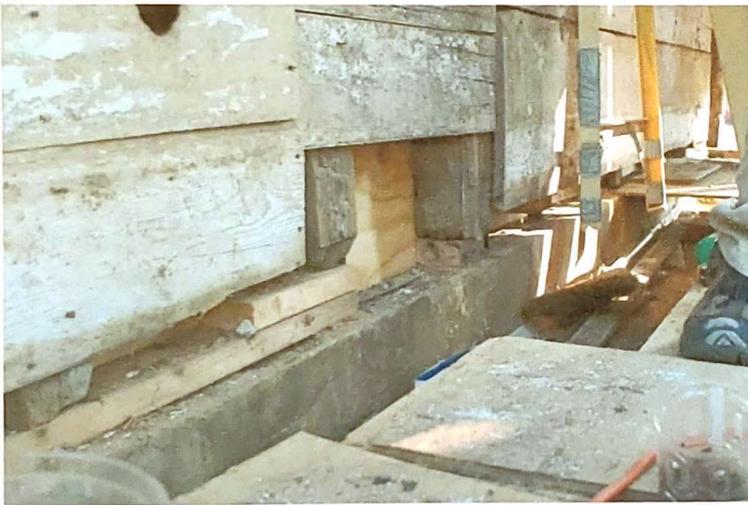
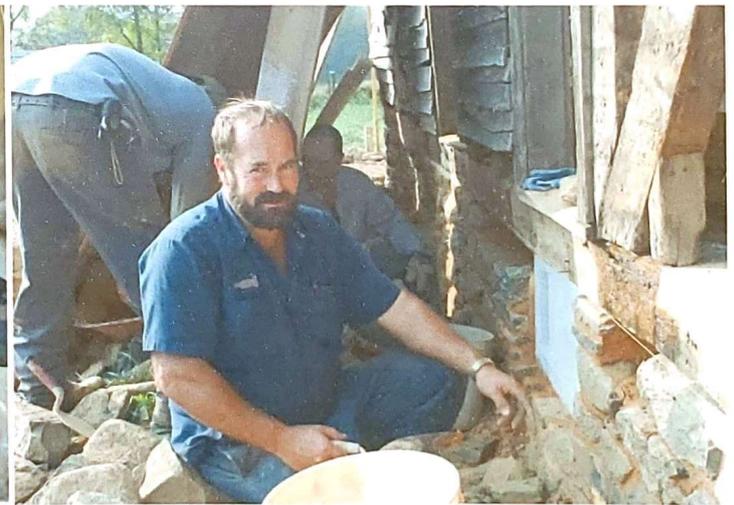
West Gable – Removal of the protective Tyvek and plywood on this chimney side exposed studs with punky bottoms, unstable deteriorated joints, a replacement north down brace hanging precariously and a severely rotten and split upper oak plate due to years of unabated water penetration. The Abatron and/or West System wood epoxies again stabilized and preserved the ends of the damaged timbers, and Mike spliced in new oak tenons on those that had lost them so the uprights could be fastened into the sill. The method preserves the craftsmanship and materials of the Marshall period as well as later repair campaigns to every extent possible.

Lots still to do on a waning calendar for the October 1<sup>st</sup> visitation marking the 250<sup>th</sup> birthday of John Marshall and too little vertical space to insert new tenons in situ, Mike devised a faster stacked 2 x 4 base solution to bring the dangling rotted-off ends of the uprights down to the east sill at the southeast end (shown in the photograph at lower left). The approach is an acceptable preservation method that retains more of the original stud while distinguishing the period-one workmanship from this stabilization campaign. Also this week, Mike fully reapplied the horizontal paneling on this east interior wall. Simultaneously, Edward and crew continued restoring the south front foundation. The lean-to shelter providing shade for Miguel is not there for his comfort. It is in place to prevent the hot sun from drying the common mortar too quickly when it requires a slow curing for proper hardening.

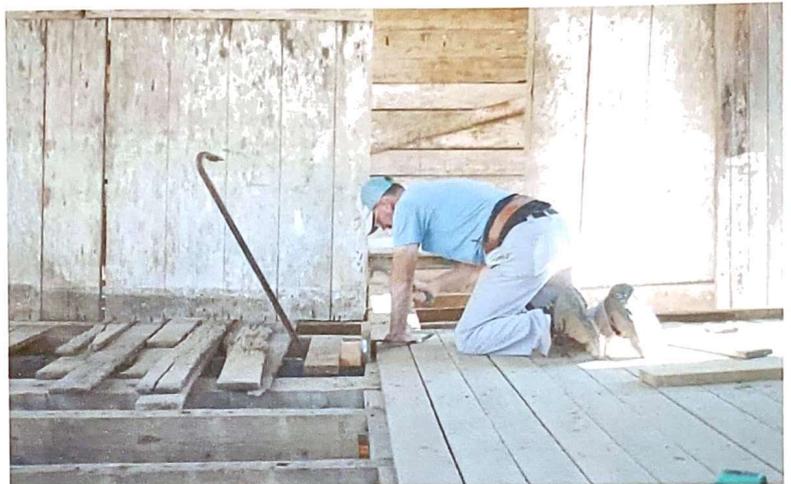
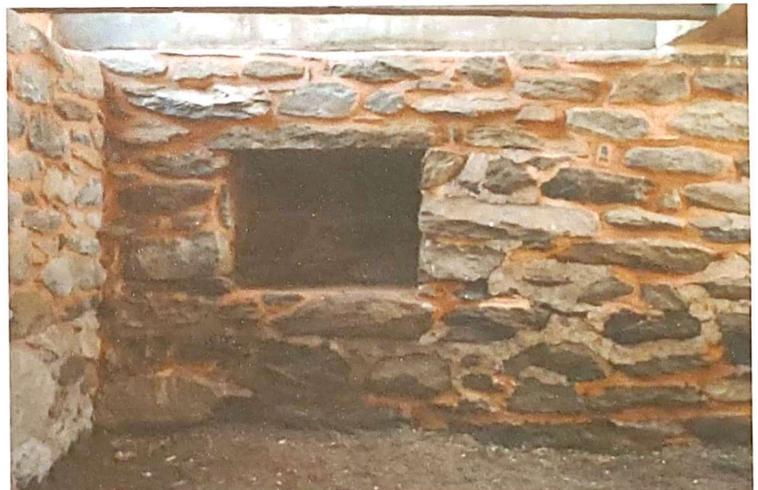
The lower right image exhibits the equally fine workmanship of the stonemasons in restoring the northeast upper corner, including the niche, of the interior east foundation wall. The failure of the back foundation and its reconstruction in the early twentieth century left this foundation disconnected. The corner had disintegrated before April 2005, but stonemasons Edward, Miguel, Alejandro and Francisco have properly keyed the back and front corners into the outer foundation during this 2005 repair.

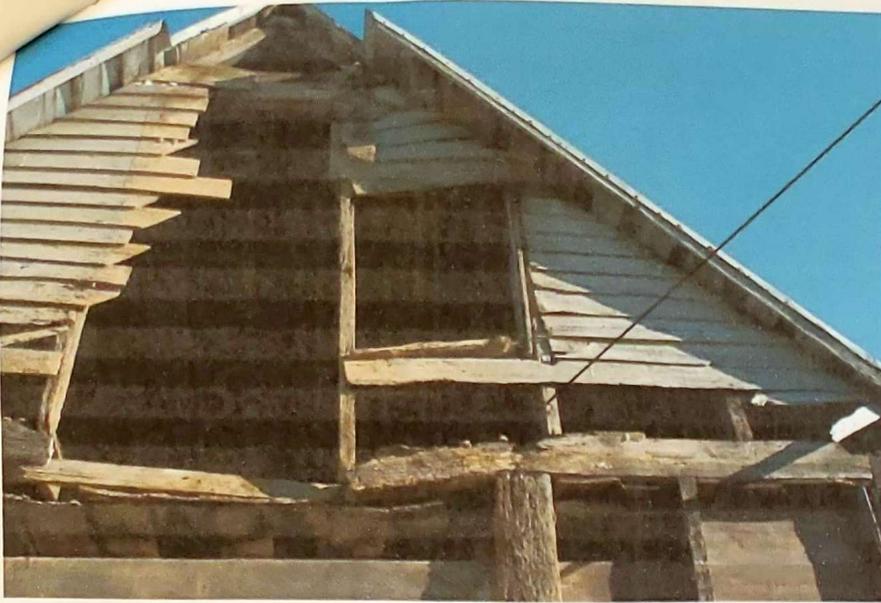
The split plate on the south-right side of the chimney location is pictured at left. Located under the garret window opening, water dripped down the stud into the mortise in the timber for a long time.

Mike consolidated the north-left plate, but had to replace the split south-right half with a matching oak timber. He applied some epoxy to the tenons of the chimney studs as well. During this process, Mike discovered a wrought shutter dog between the floor and plate under the window location. This thrilled Cheryl because the window framing was crude originally with mortises for hanging in the studs only partly present. The incompleteness left some doubt that the window was executed in this location in period one. However, the heavy weathering on the studs and the plate under the window opening indicate its long-term situation here. The shutter dog is a wonderful archaeological piece of evidence that also guides future plans for how to finish the house.
