SUMMER 2005 HOLLOW STABILIZATION REPORT #3, 18 August 2005
By Cheryl H. Shepherd, Architectural Historian/Resident Project Manager for the APVA

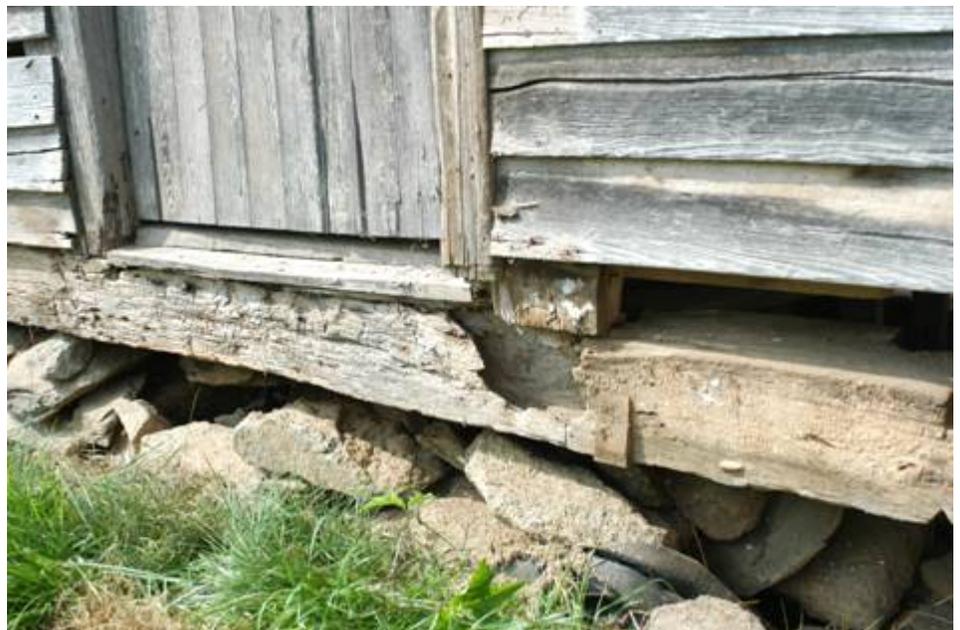
10. The first sawn 10 x 8 x 30 white oak sill for the north back arrived at The Hollow on July 5th, but it had a 4-1/2-inch bow (more than half its height) at center that we expected to worsen in time. Since we aim to correct the threatening skew in the house, adding a new member about equally bowed to the front sill's point would not have been wise in the long run, so the timber was returned. The second oak sill arrived two weeks ago, and it is quite a well cut timber by the same sawyer. Mike has adzed the inside seen from the cellar, cut the wide mortises for the major upright members into this sill, and the floor joist mortises are started.

At every week's end, we speculate that this major sill will be inserted by the end of the next week. Yet, Mike is working alone on heavy old oak timbers, consolidating deteriorated portions with epoxies which have to be layered and dried before the next coat, anchoring ends with brackets when absolutely necessary, hand hewing, planing, cutting mortises in receiving timbers and preparing the few replacement members for insertion. In addition to strength and good balance, it requires meticulous measurement and re-measurement especially when the new weighty timbers are still outside the building. He is a super timber framer.

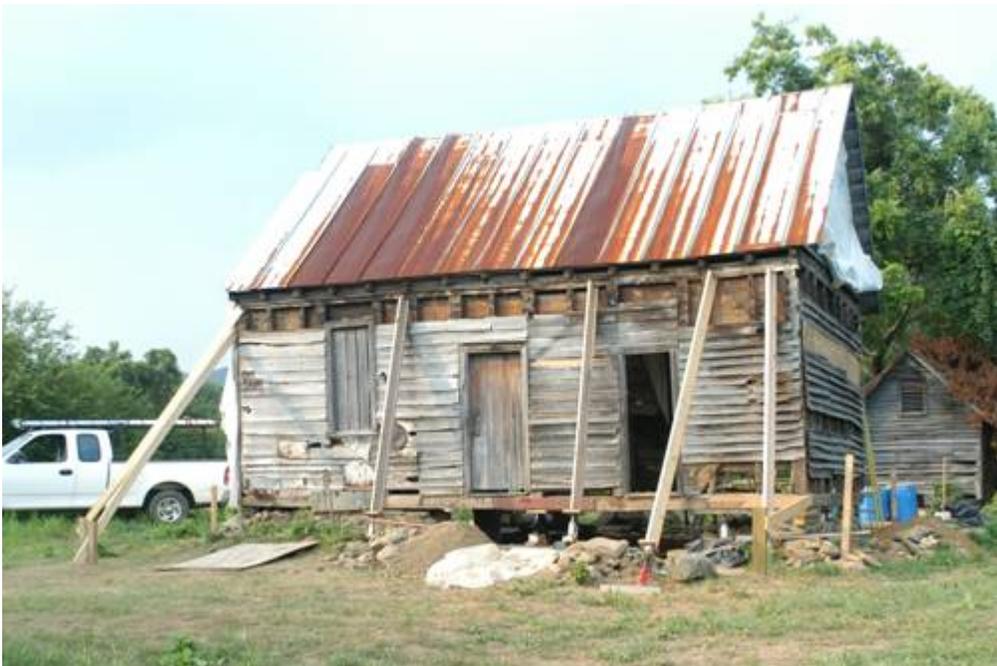
Photographed on the 2nd of August after many periods of measured jacking, notice the house is leveling quite nicely in comparison to the photograph on the first page.

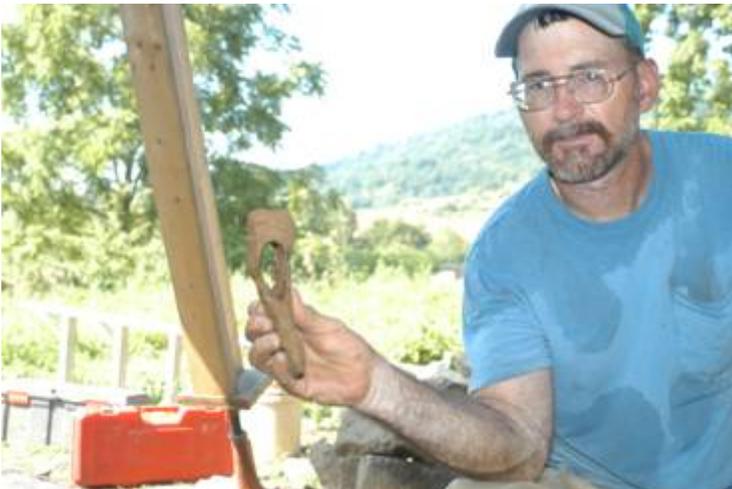
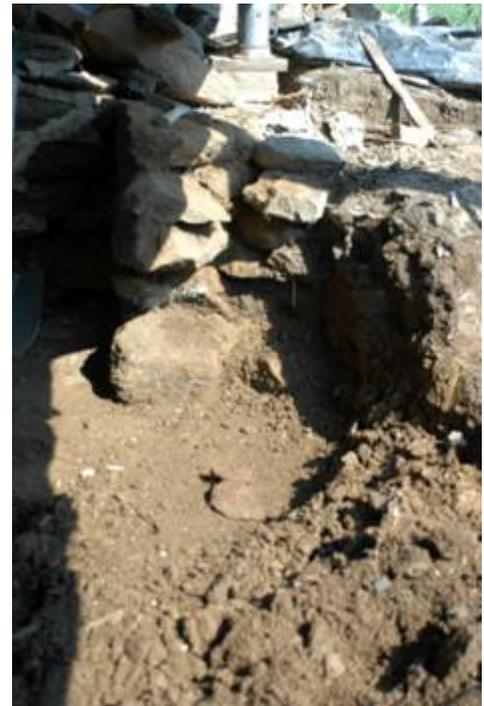
The side-axe head laying in the dirt as uncovered at the bottom of the front foundation and in Mike's hand on July 18, 2005.
