SUMMER 2005 HOLLOW STABILIZATION REPORT #4, August 29, 2005

By Cheryl H. Shepherd, Architectural Historian/Resident Project Manager for the APVA

REPAIRING THE HOLLOW DWELLING STEP BY STEP, *continued* -

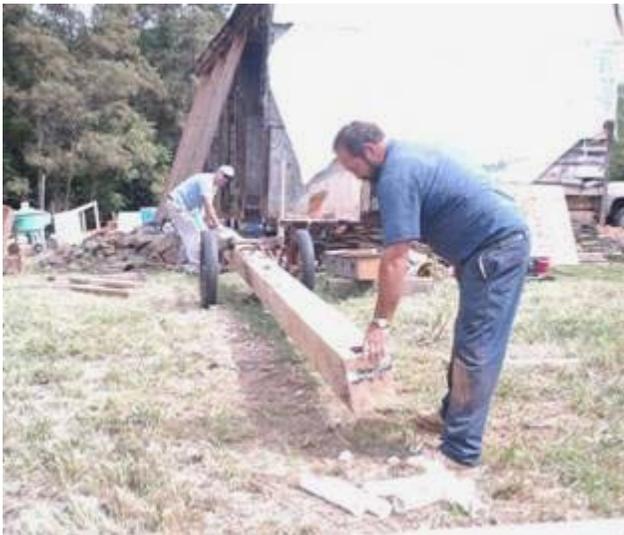
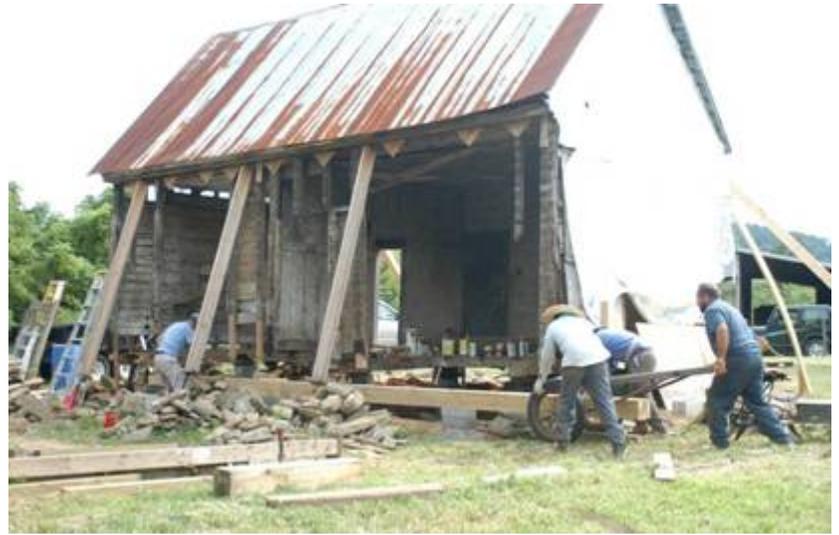
Using a log cart in the left view above, Edward and Mike are rolling the new white oak south sill down the line to the back of the building. In the right view, Alejandro and Miguel have joined their labors to the hefty task, August 25, 2005.

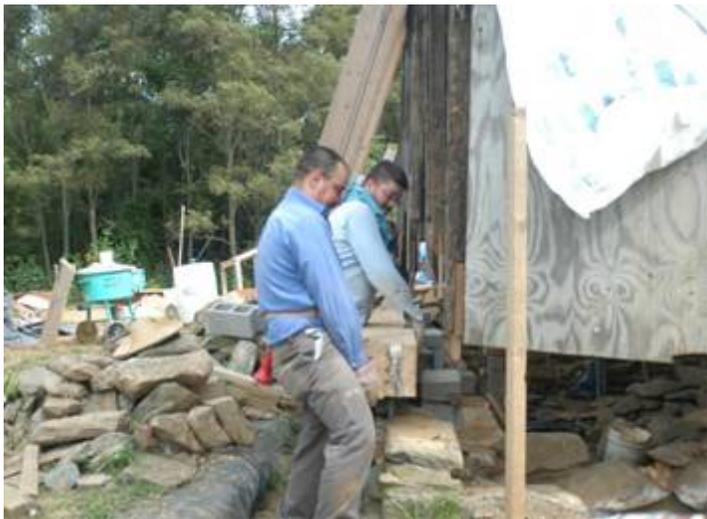
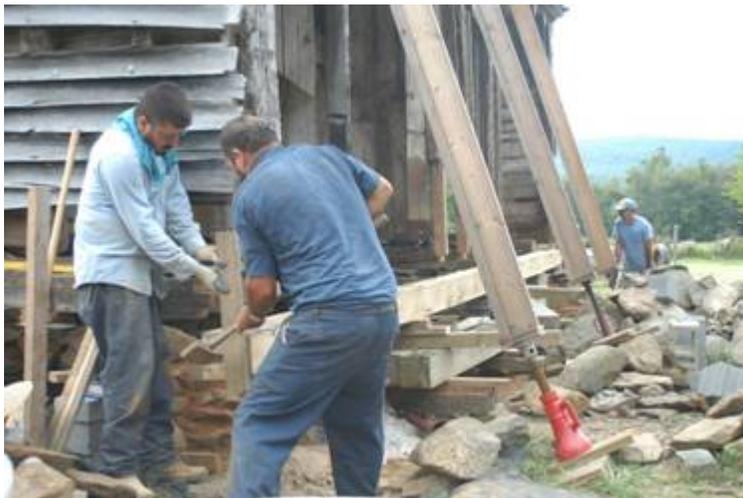
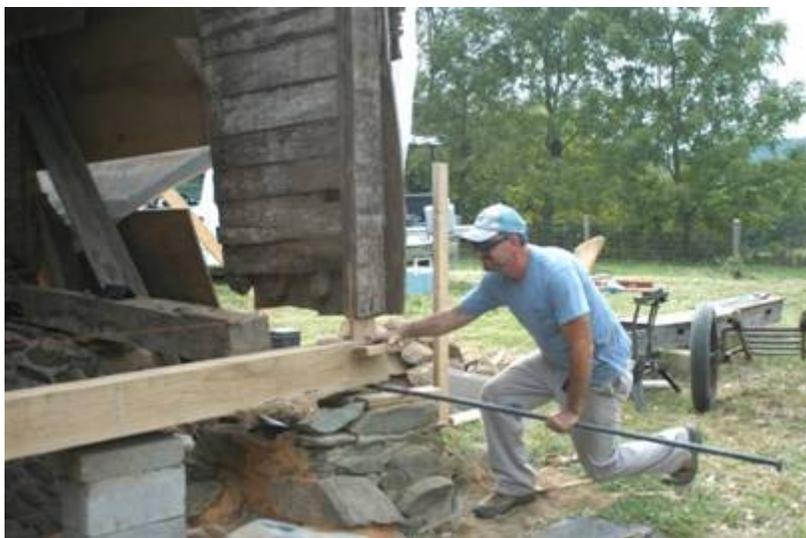
Miguel and Alejandro share the weight burden at the west end in the left picture. Alejandro assists Edward as he forces the sill back to the west to more closely align with the corner post position Mike is watching, 8/25/2005.

Mike has to lift the west end while the timber is being driven toward him. The photograph on the right shows the sill where Mike wants it to finish the ends of the studs.

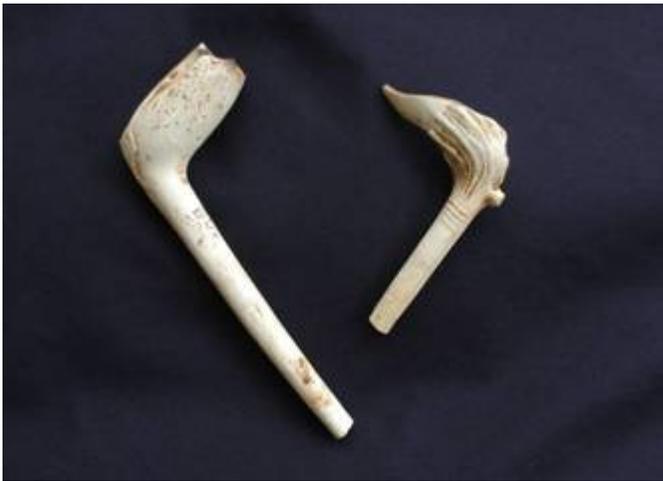
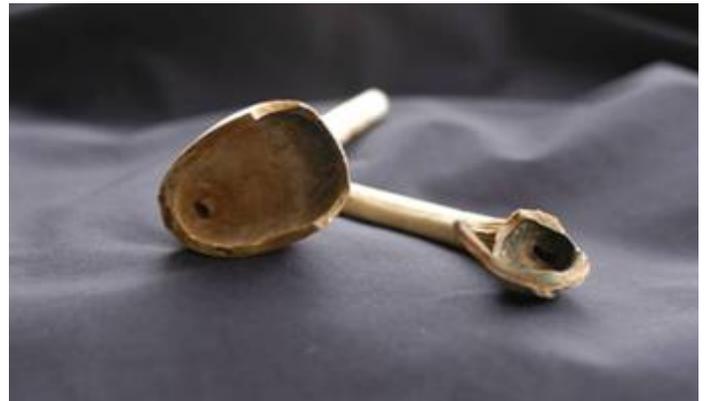
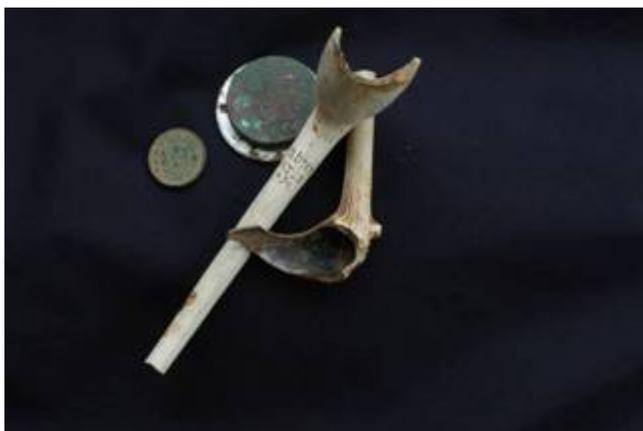
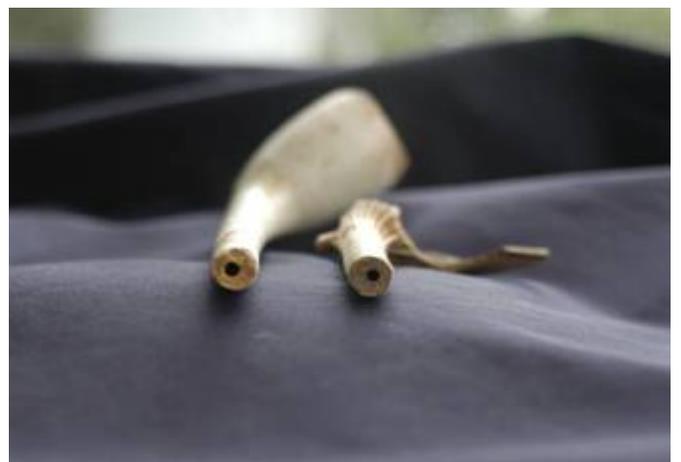
Views of the clay pipes. Balancing the pipe, the 1806 large cent is lying on a Baltimore-Markham railway token. The 1953 Danish dime was lying on the ground in front of the house where the demolished two-story dwelling stood.
