## SUMMER 2005 HOLLOW STABILIZATION FINAL REPORT #5 - WEEKS 14-20

By Cheryl H. Shepherd, Architectural Historian/Resident Project Manager for the APVA

REPAIRING THE HOLLOW STEP BY STEP, *until the season's closure in November* –

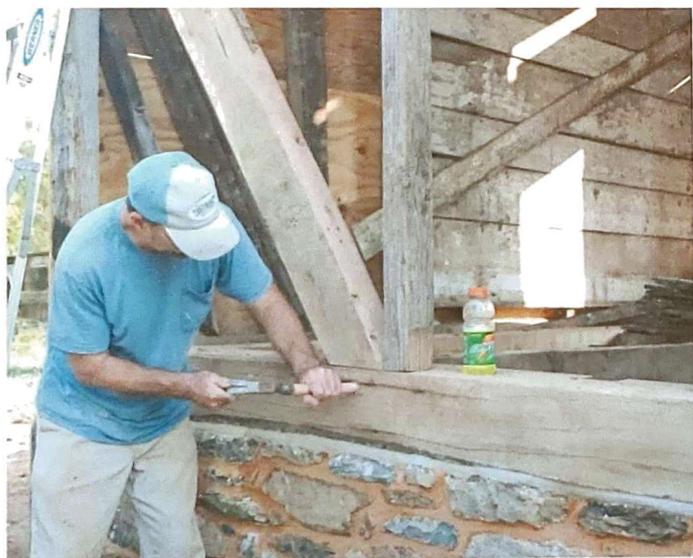
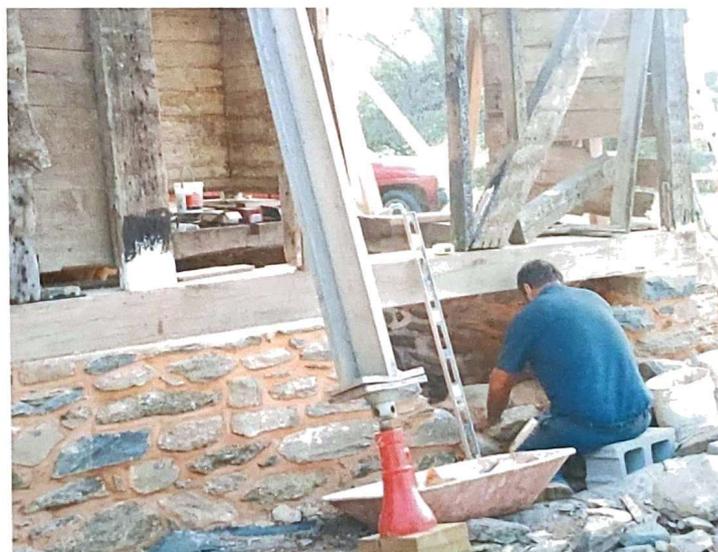
Above left, Mike and Edward place the northwest corner window into position, while Mike is shown above right anchoring the southeast window under the original lathing strip.

Finally, Mike hammered his hand-made treenail through the sill and east down-brace tenon. In the meantime, Edward and crew brought the north foundation wall up to the sill and prepared jambs for the cellar window that the team has determined necessary for ventilation of the lower space. Made in the APVA shop by Robert Stinger, Mike and Edward also inserted a second cellar window diagonally across from the back opening on the front corner. As earlier reported, the evidence of a cellar window on the southeast front corner clearly remains in the wrought-nailed lathing strip under the sill which served to shim or tighten the component. The circa 1900 major repair of the north stone foundation obliterated any potential evidence of a cellar window on the northwest corner of the back wall, but there were signs of a suspected cellar entrance at the site of the new window. (See Report #5.) The Hollow windows are whitewashed as Thomas Marshall would have done. After additional coating in 2006, wire mesh screens will be stapled on the inside of the windows to deter rodents and other wildlife invasion.

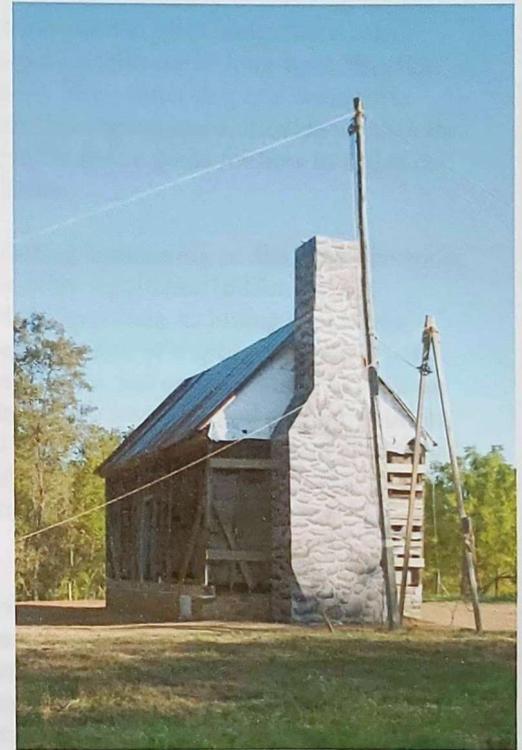
The split plate on the south-right side of the chimney location is pictured at left. Located under the garret window opening, water dripped down the stud into the mortise in the timber for a long time.

Mike consolidated the north-left plate, but had to replace the split south-right half with a matching oak timber. He applied some epoxy to the tenons of the chimney studs as well. During this process, Mike discovered a wrought shutter dog between the floor and plate under the window location. This thrilled Cheryl because the window framing was crude originally with mortises for hanging in the studs only partly present. The incompleteness left some doubt that the window was executed in this location in period one. However, the heavy weathering on the studs and the plate under the window opening indicate its long-term situation here. The shutter dog is a wonderful archaeological piece of evidence that also guides future plans for how to finish the house.
